MISHAWAKA FIRE DEPARTMENT
Bryon P. Woodward
Chief of Department

October 25, 2017

RE: Variance number 18023
De Amicis Mutual Aid Society

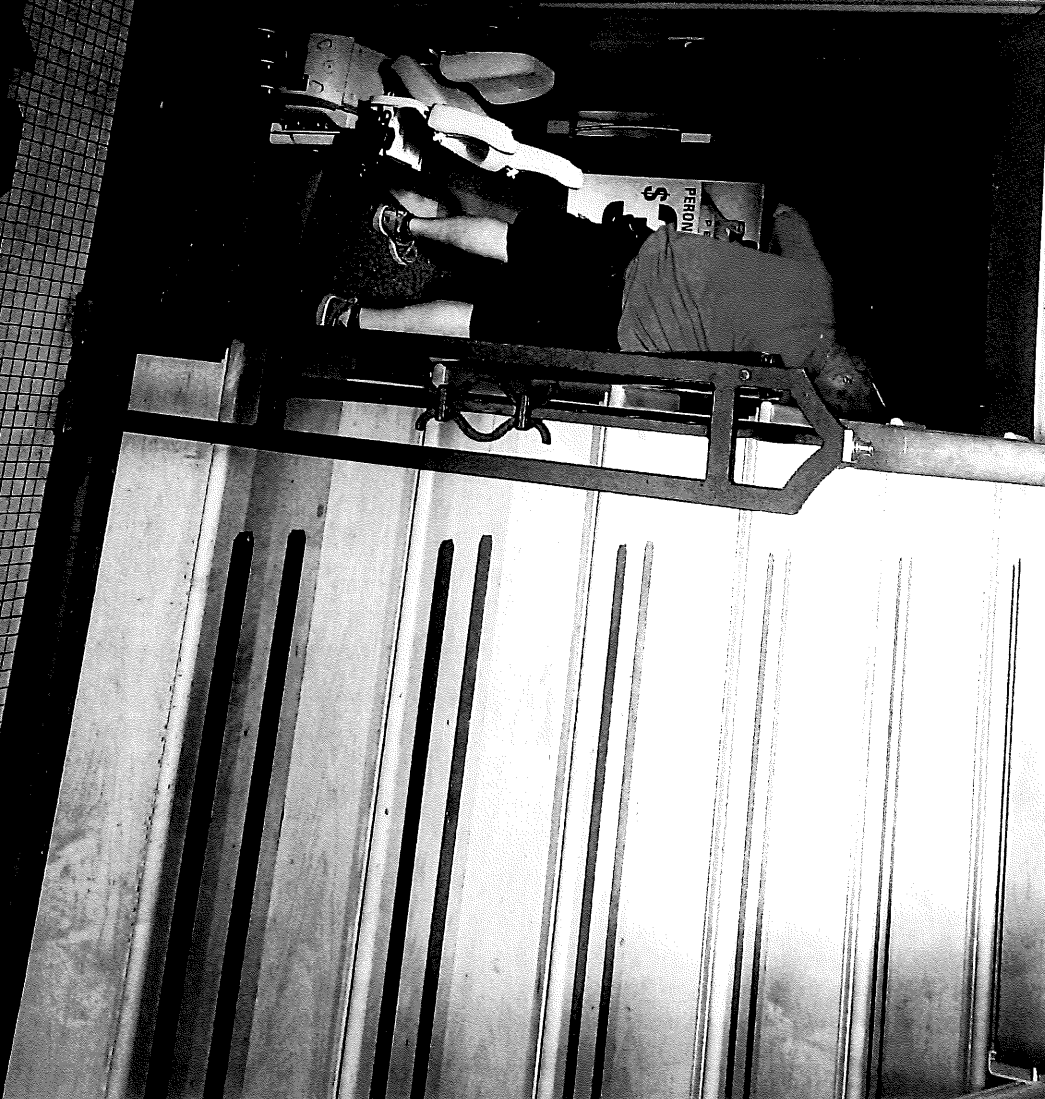
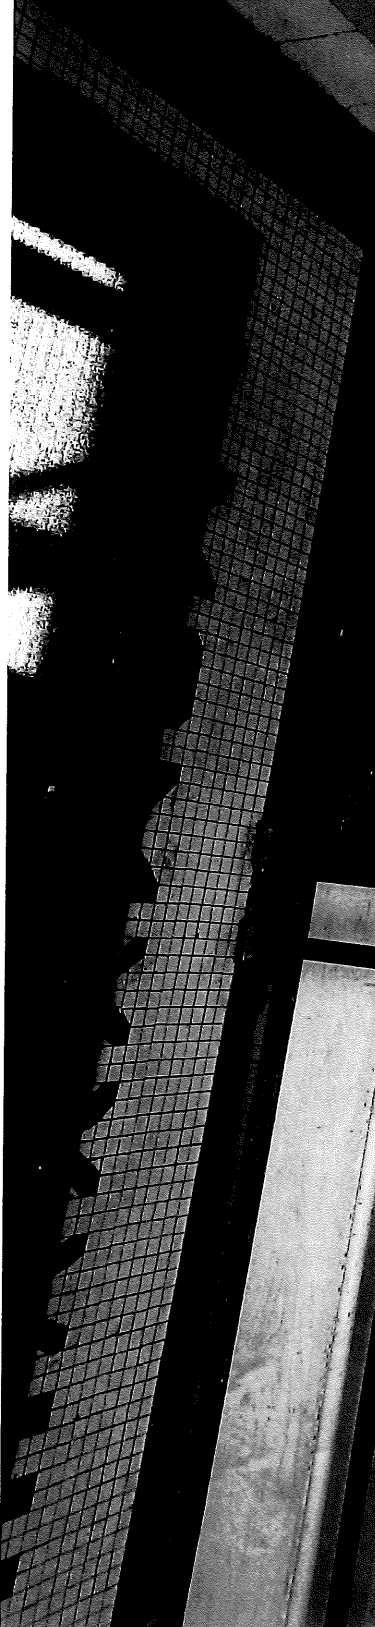
Exhibit D shows the stairs with the chair lift.

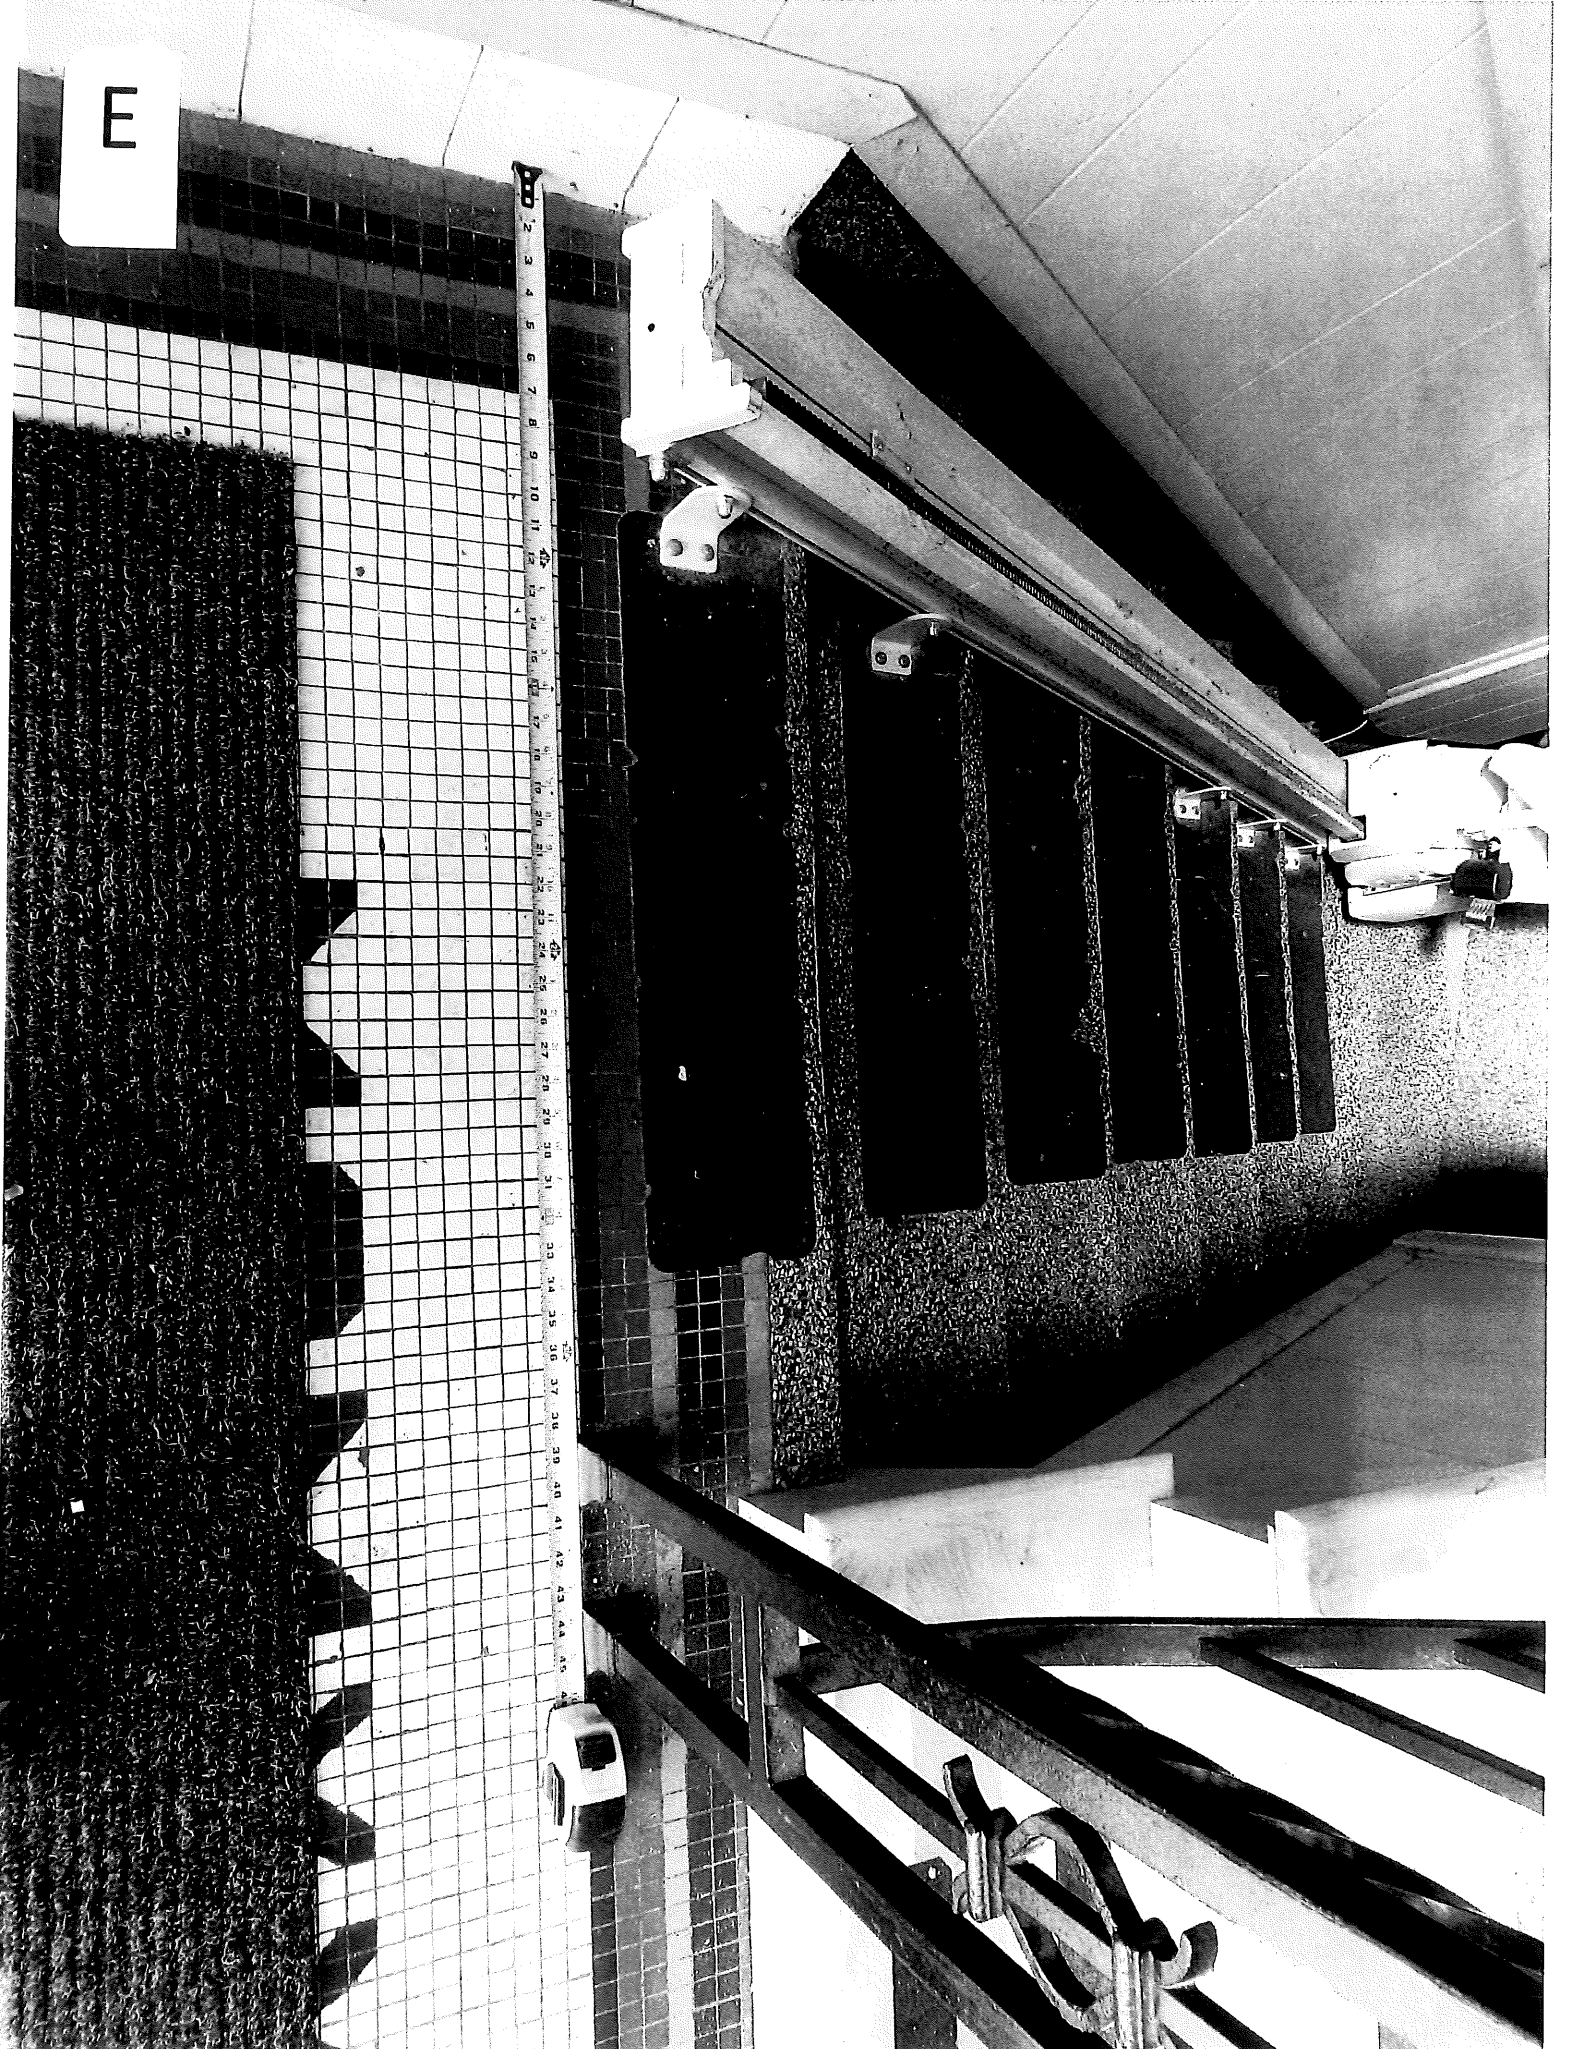
Exhibit E and F shows the measurement width of the stairs

The staircase measures approximately 38 5/8" at the widest point. Exhibits E and F. The staircase measures approximately 25 1/8" at the widest point of the lift. Exhibits G and H. This is not including the handrail which is 3 3/8" which makes the stairs 21 5/8" at the widest point from the chair to the handrail. The stairs were built to accommodate the occupancy load for the basement. With installing the lift it compromises the Means of Egress Continuity, Section 1003.6.

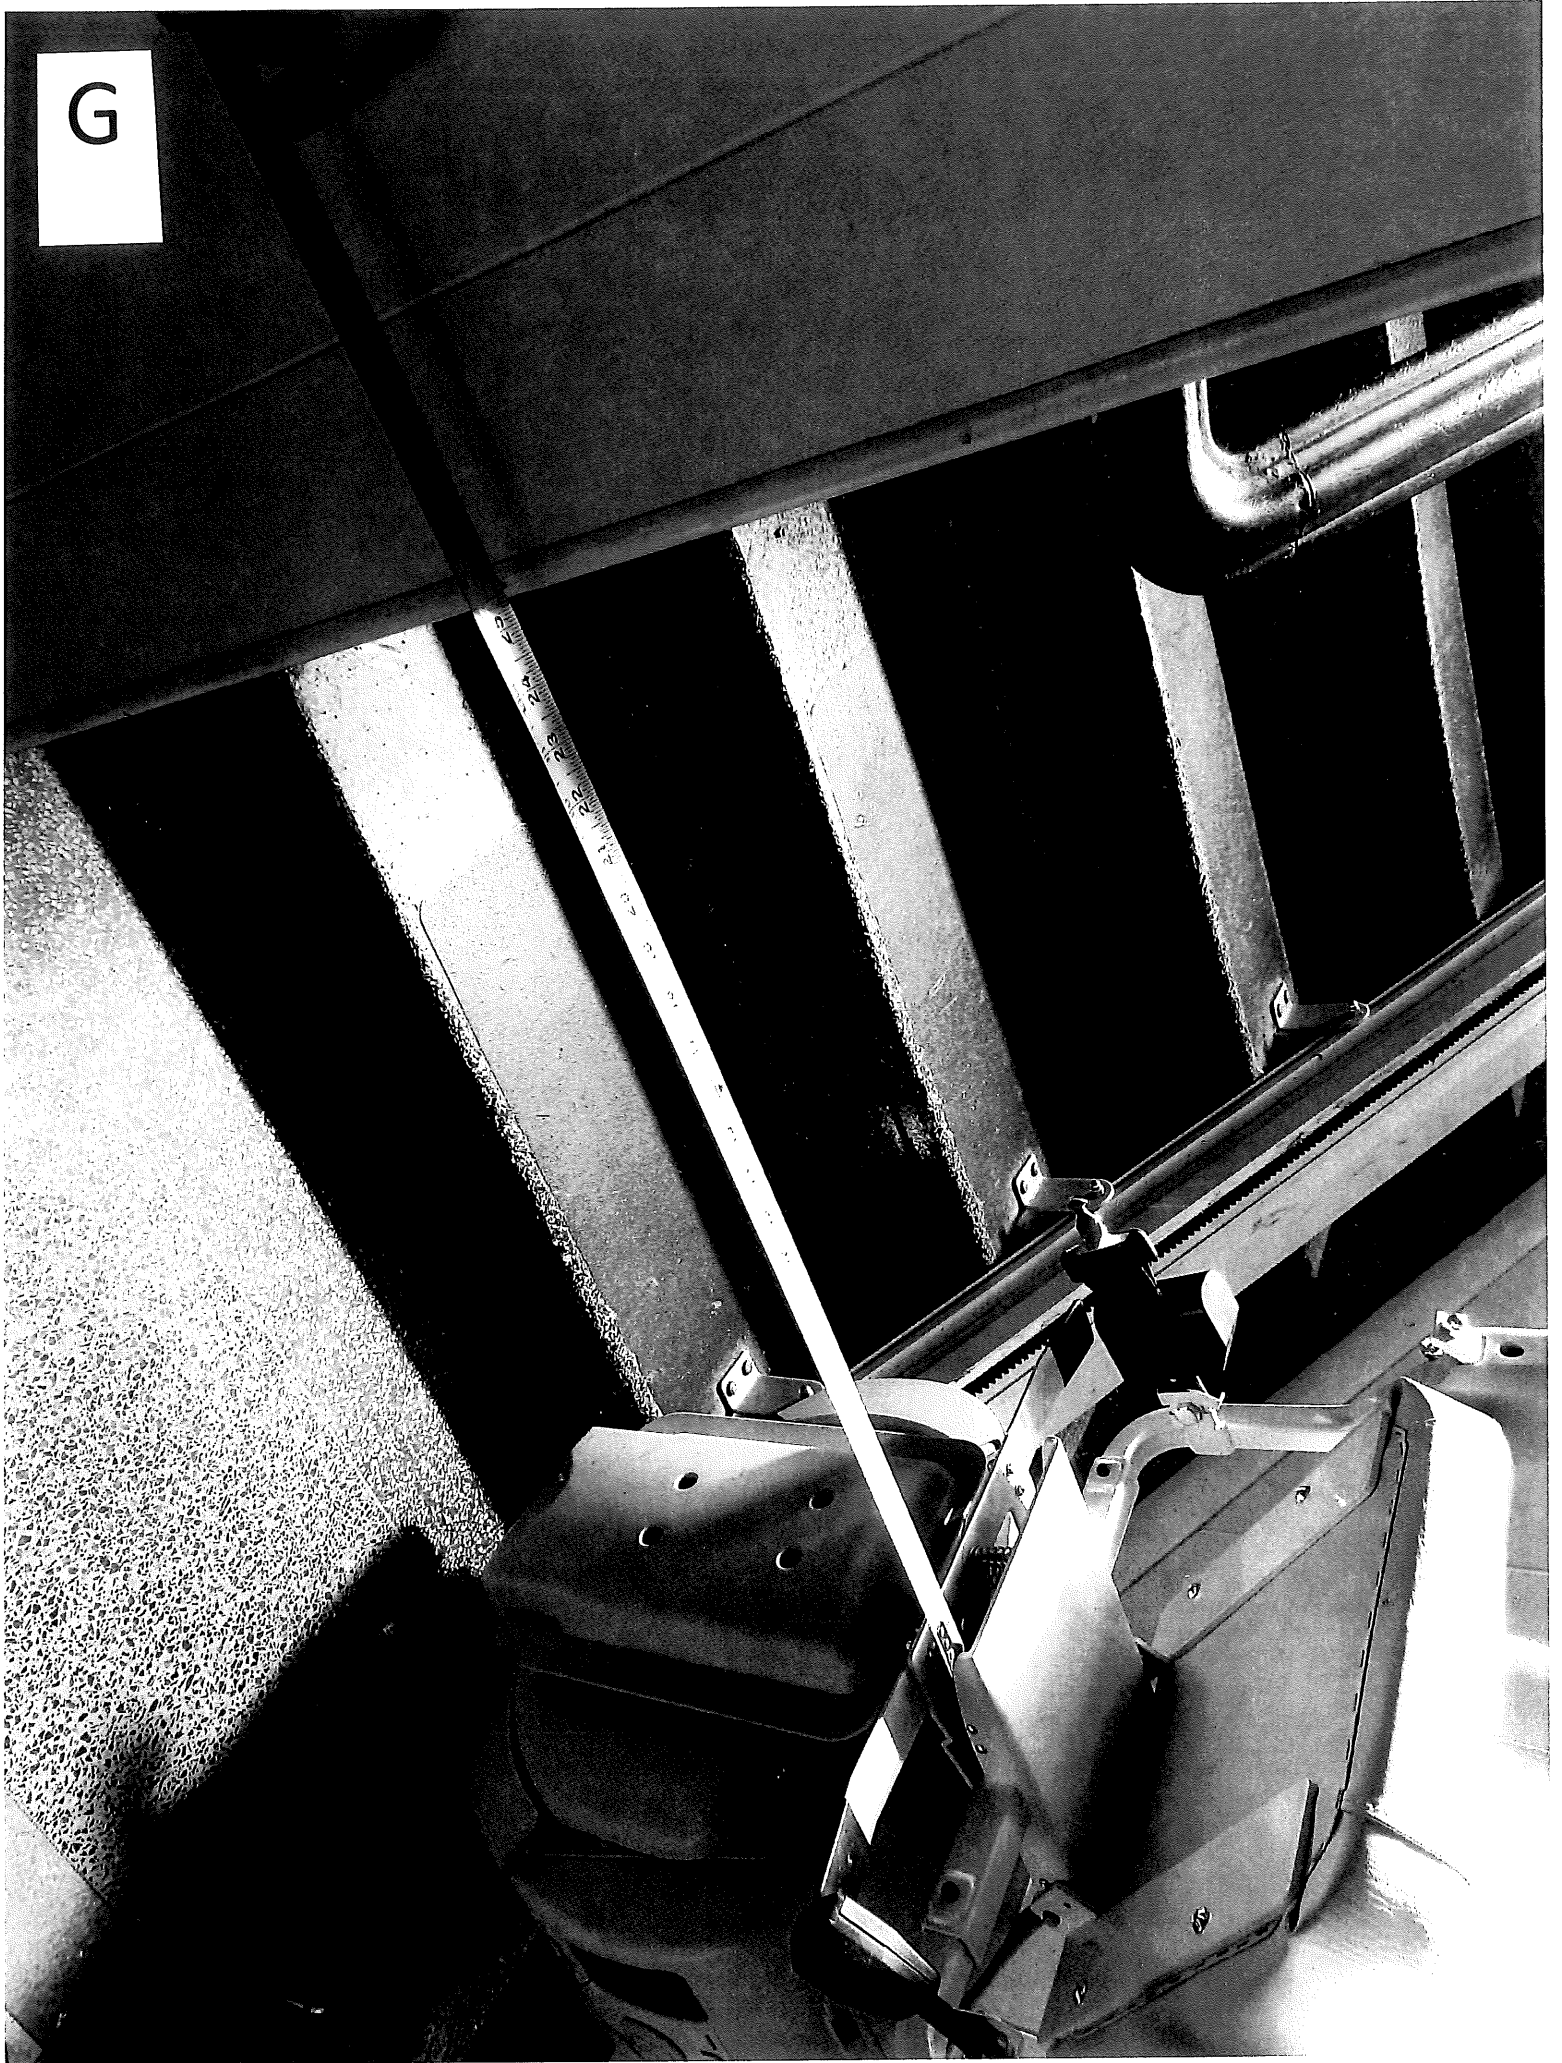
Exhibit G and H show the measurement width of the stairs at the front edge of the lift to the opposite wall.

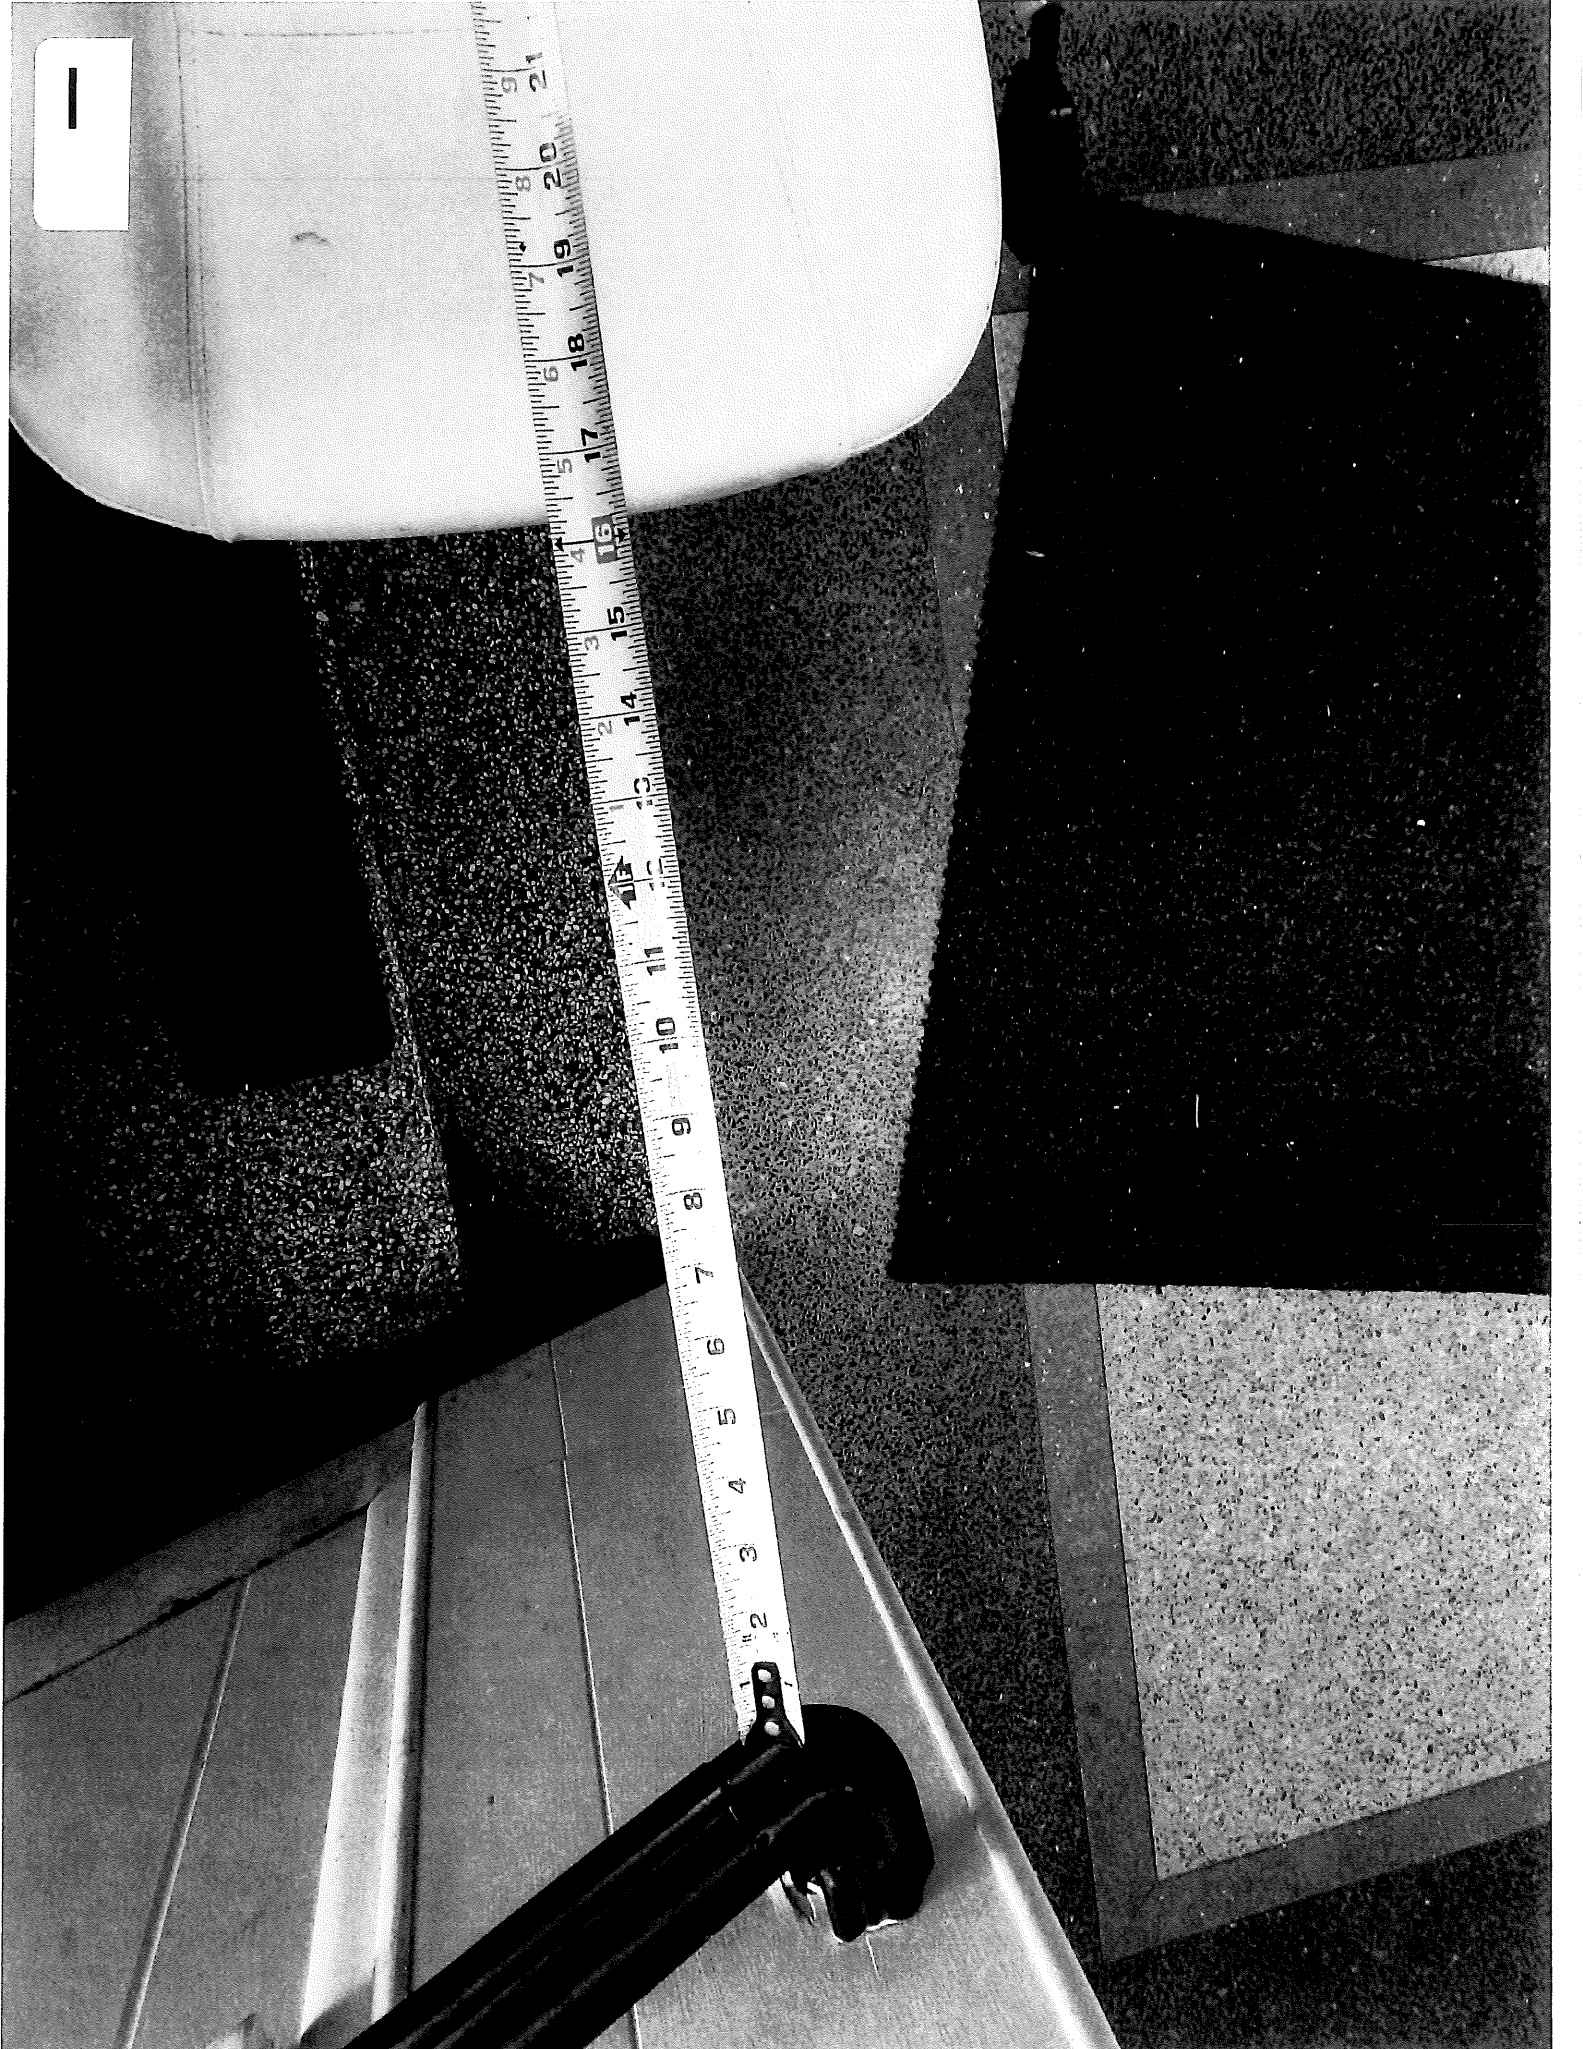
Exhibit I and J shows the measurement from the front edge of the seat in the down position to the opposite wall.

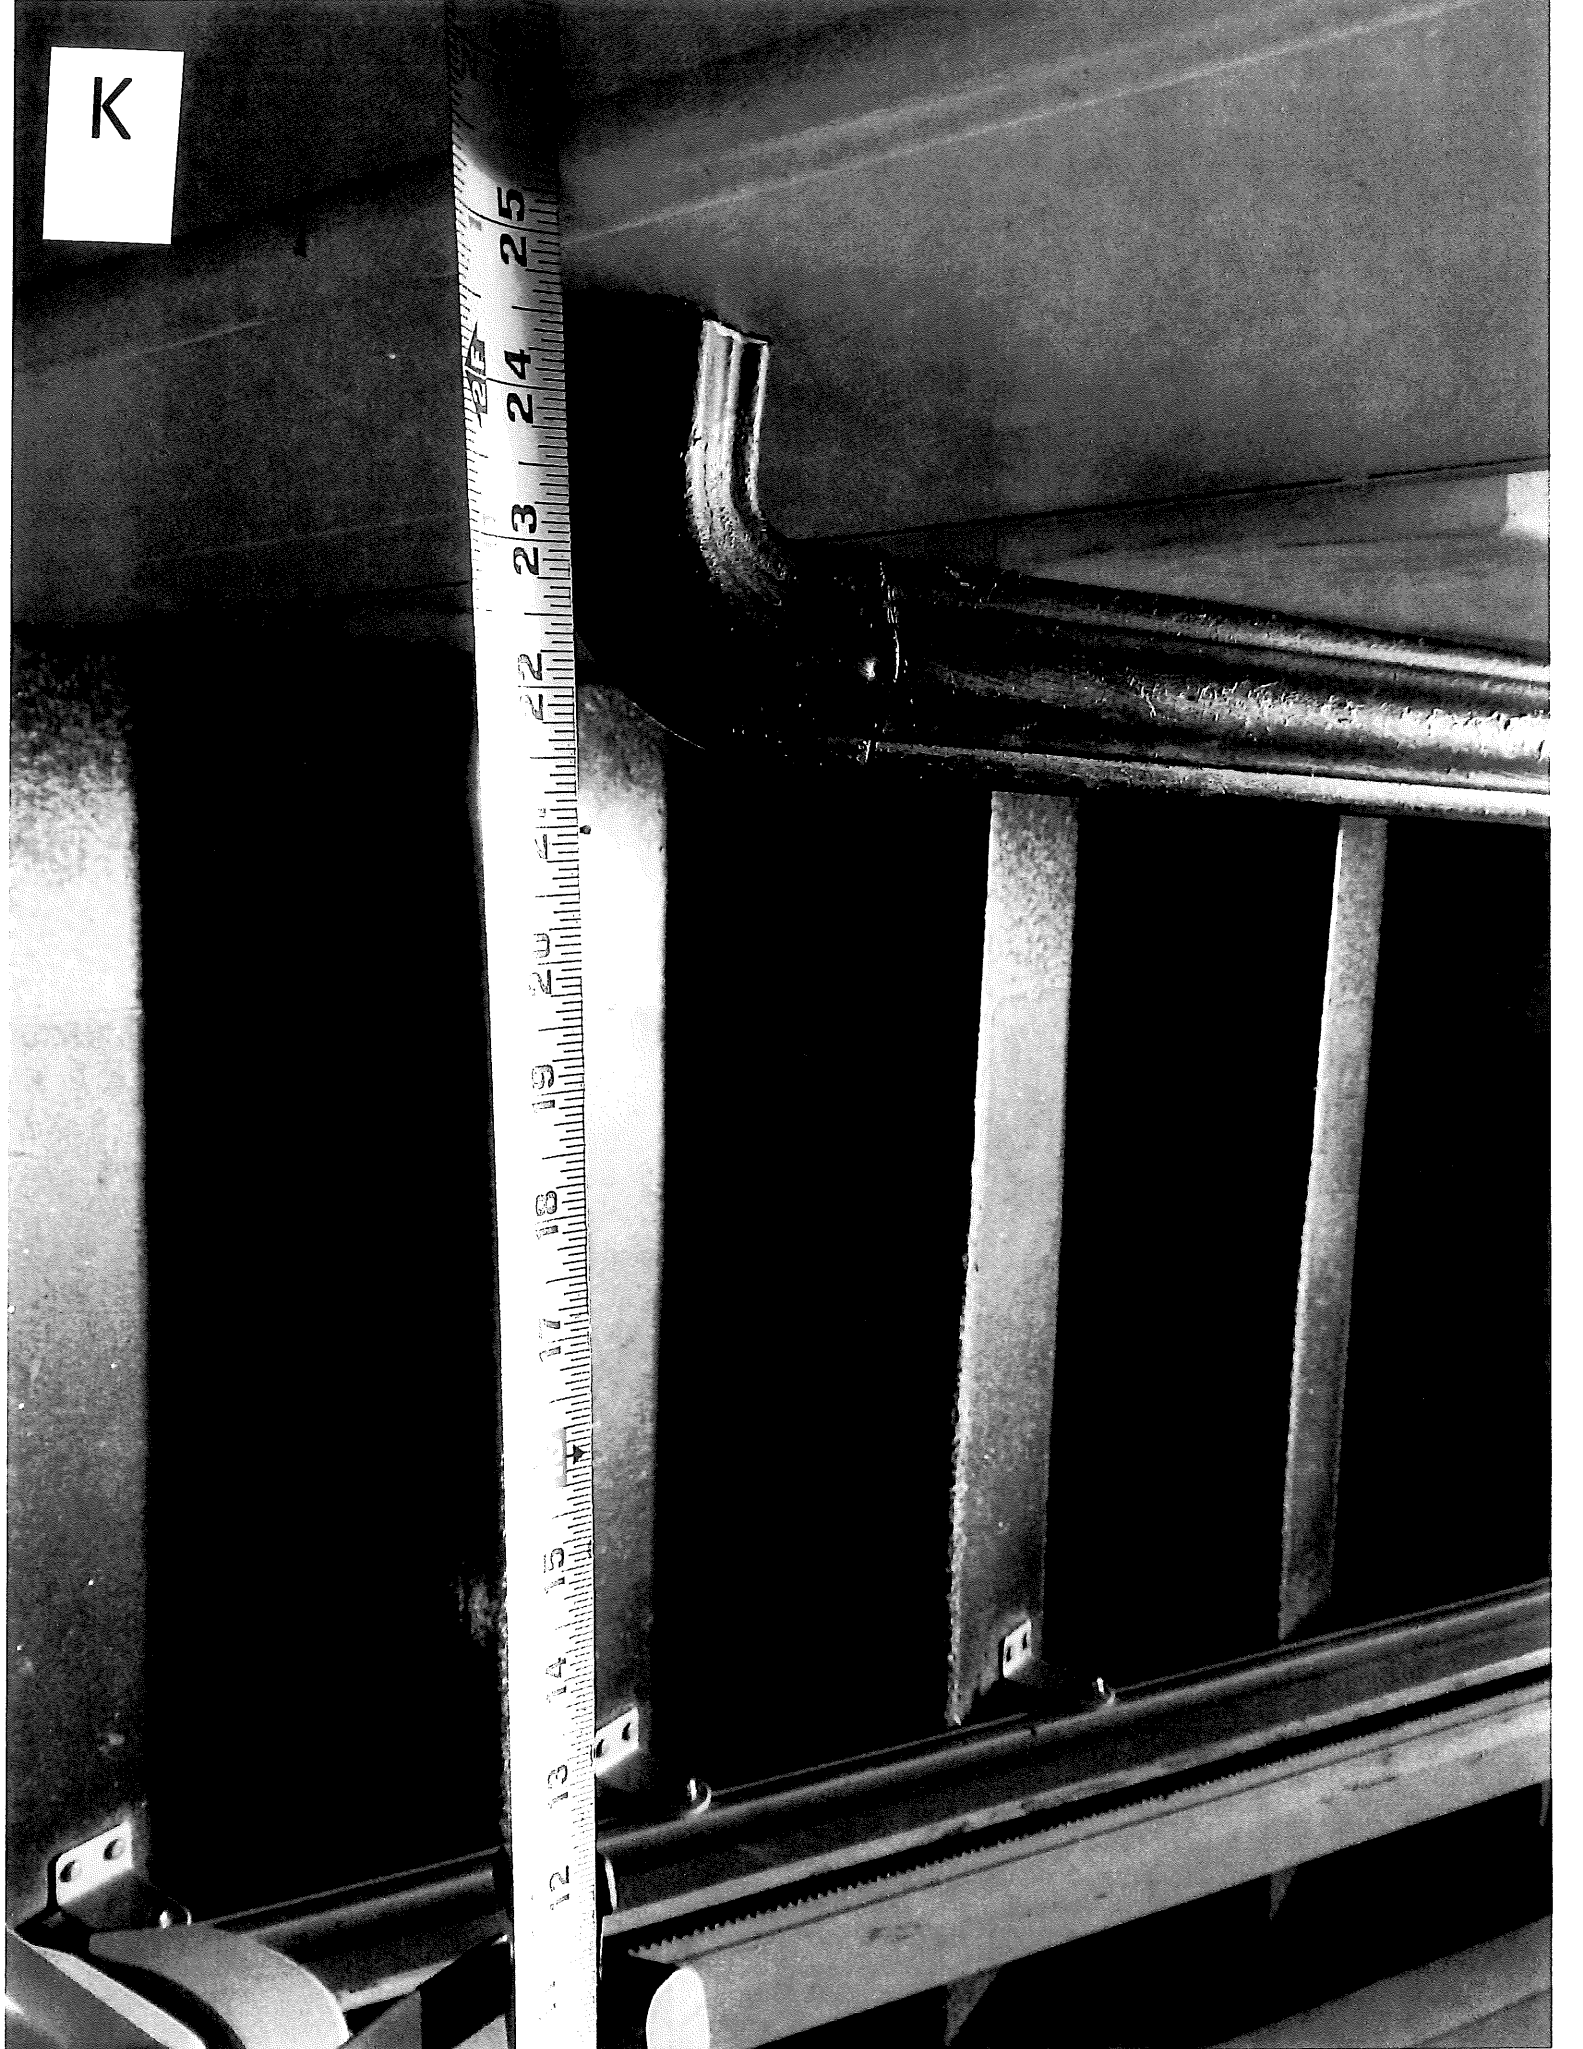
Exhibit K shows the measurement width from the front edge of the lift to the opposite handrail

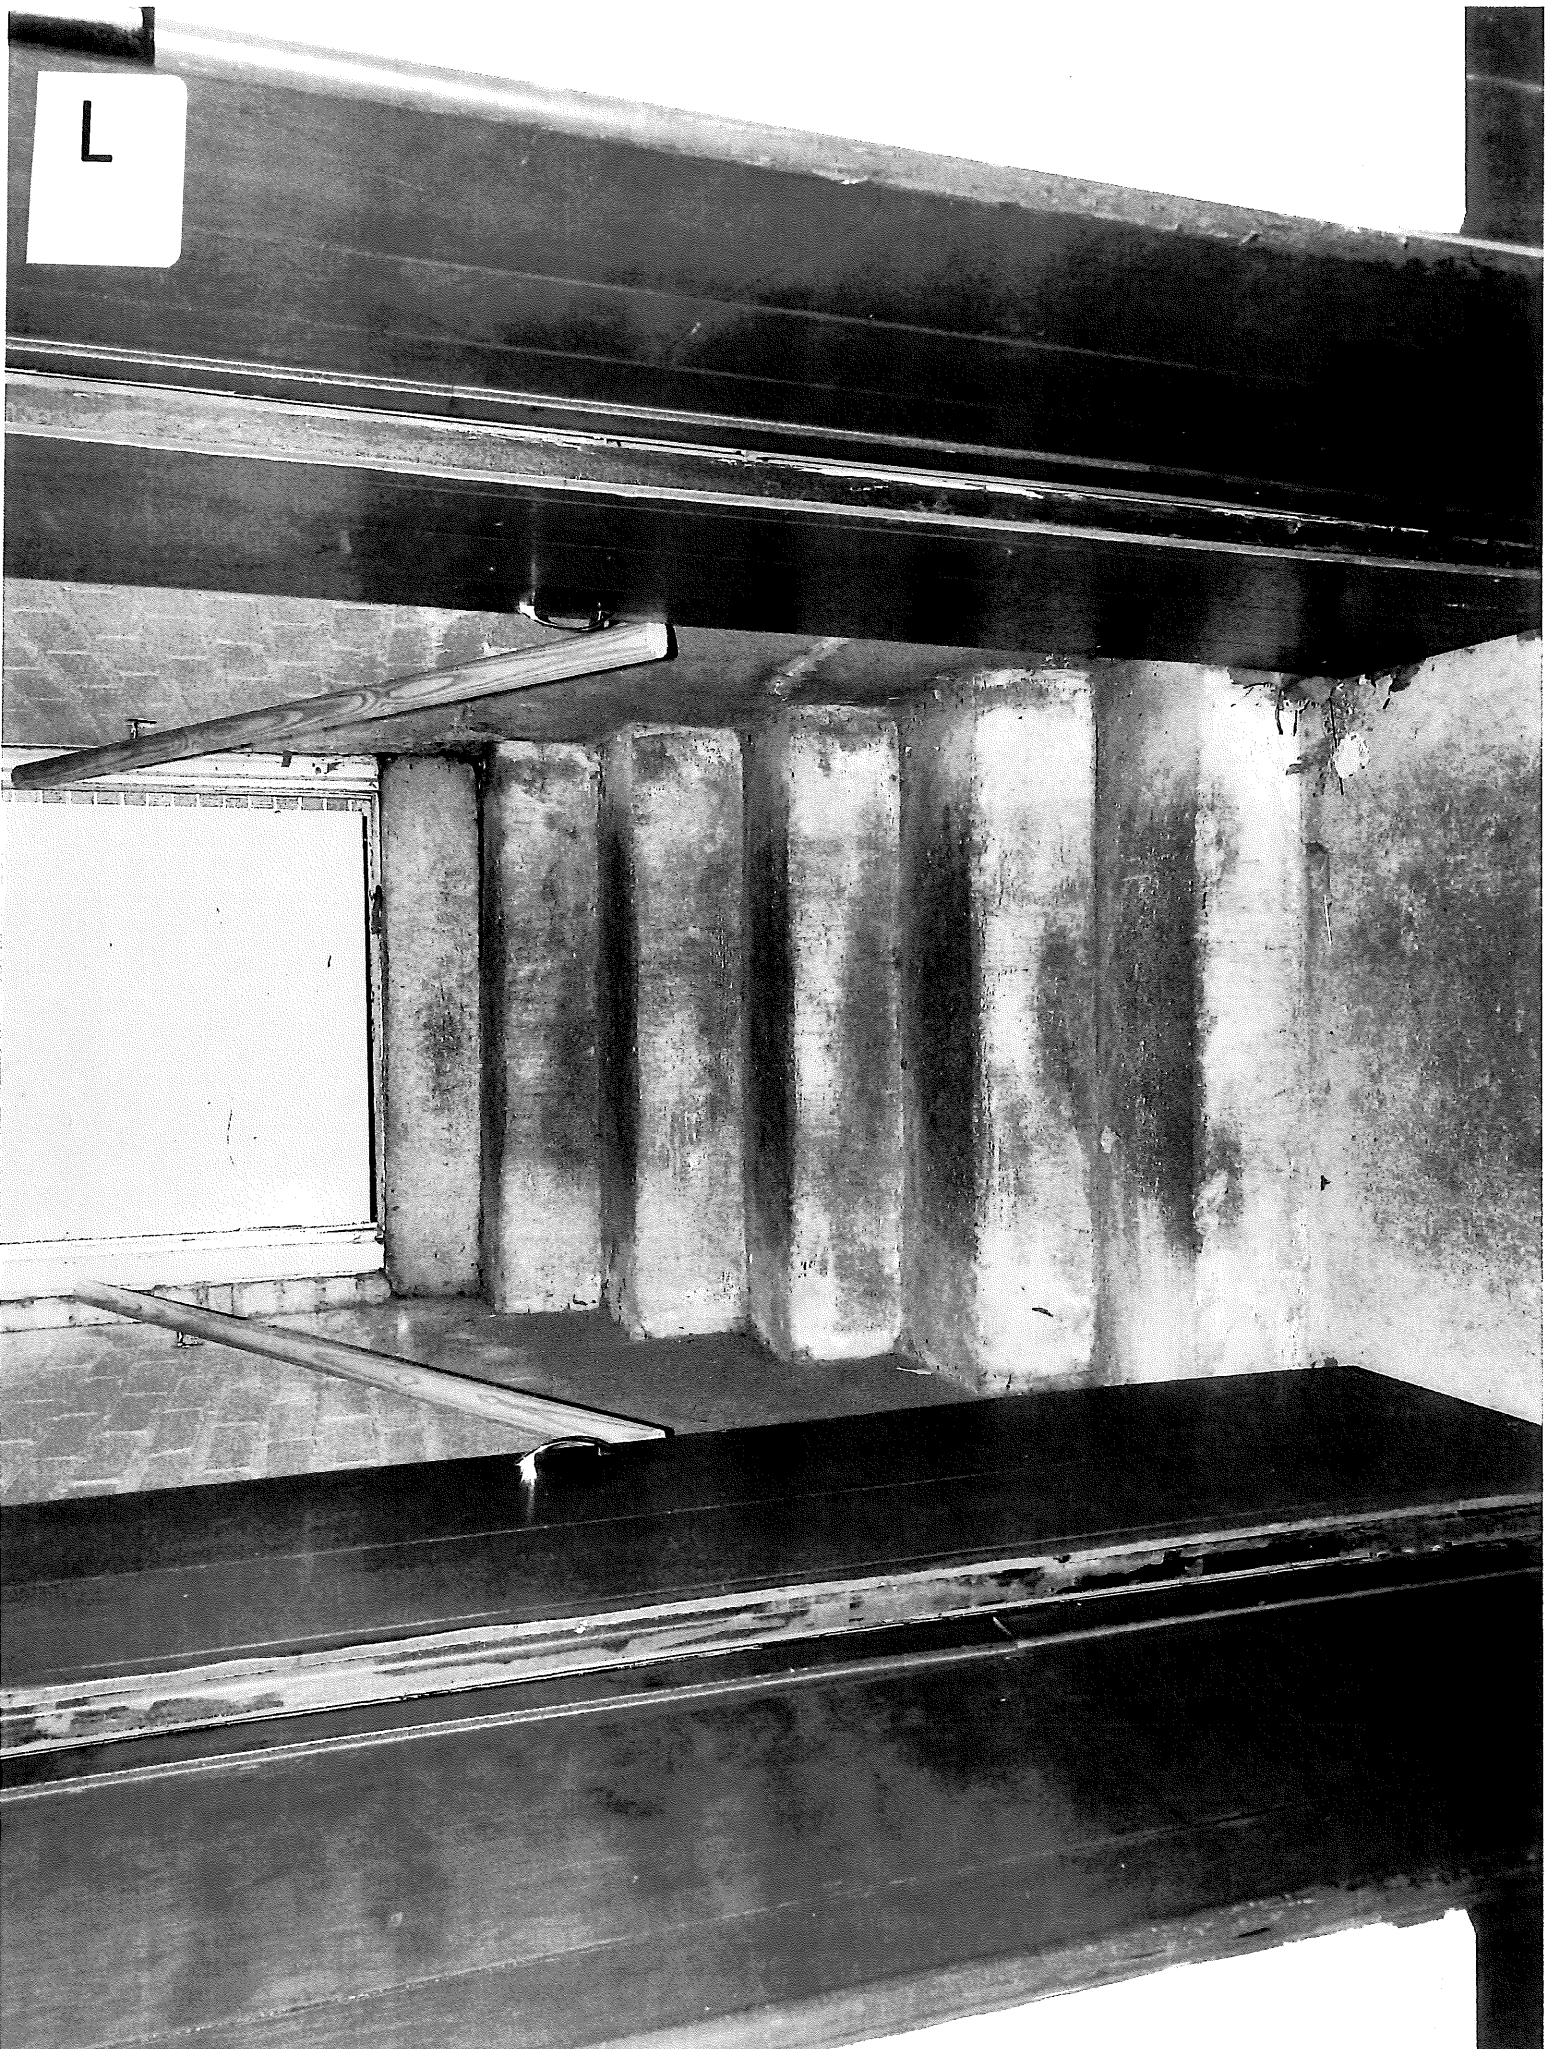
L

In the variance they mention a second exit from the basement. This exit is not maintained regularly. The stairs are made of concrete. Exhibit L. The rise of the steps is shown in Exhibit M. The treads are of different sizes. Exhibits N, O, P, Q, R. The exhibits were photographed from the lower level to the exit door. The treads range in depth from 8 5/8" to 9 7/8". The treads do not have a slip-resistant surface in accordance with Section 1003.4 IBC.

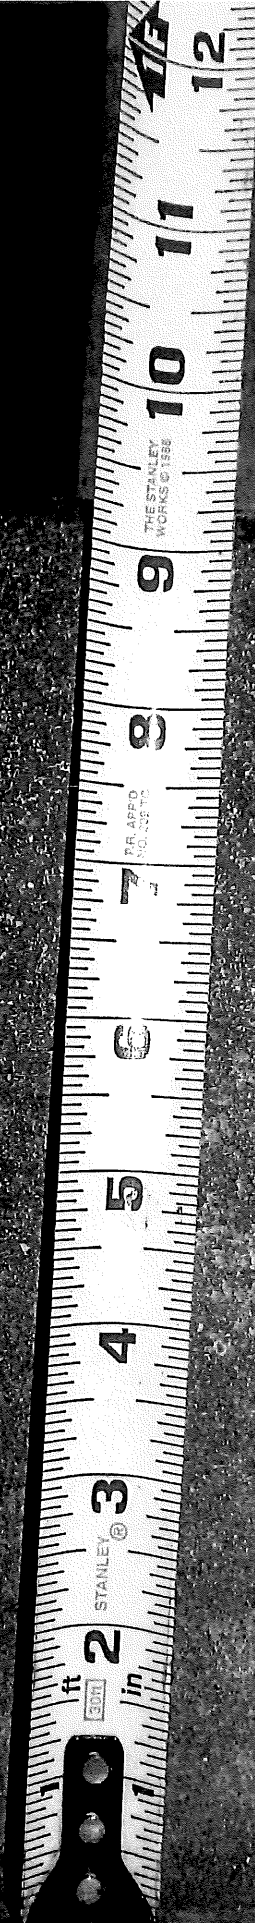
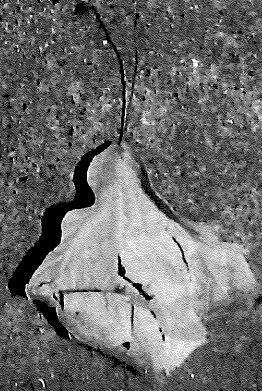
Exhibit N is the first step out of the lower level

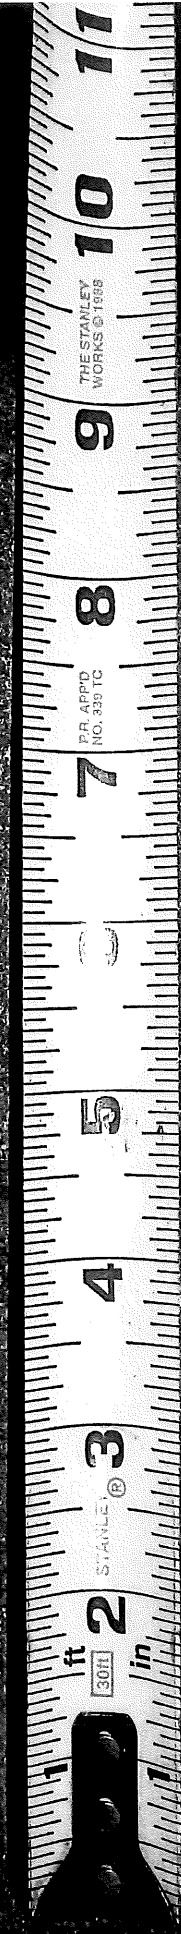
Exhibit Q is the fourth step out of the lower level.

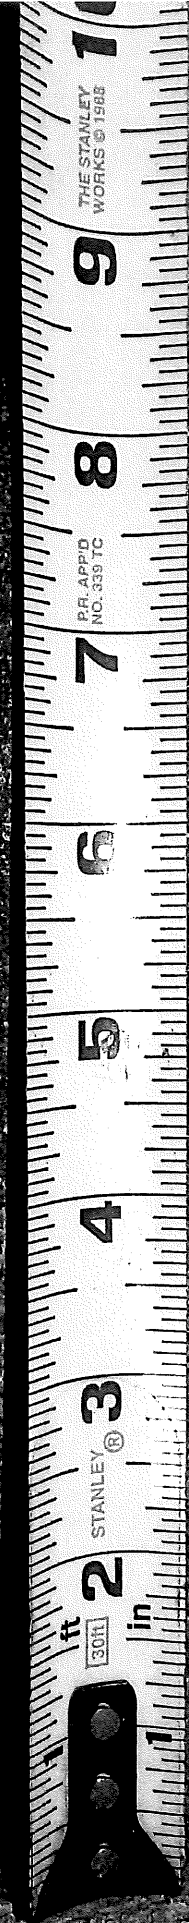
Exhibit R is the fifth step out of the lower level

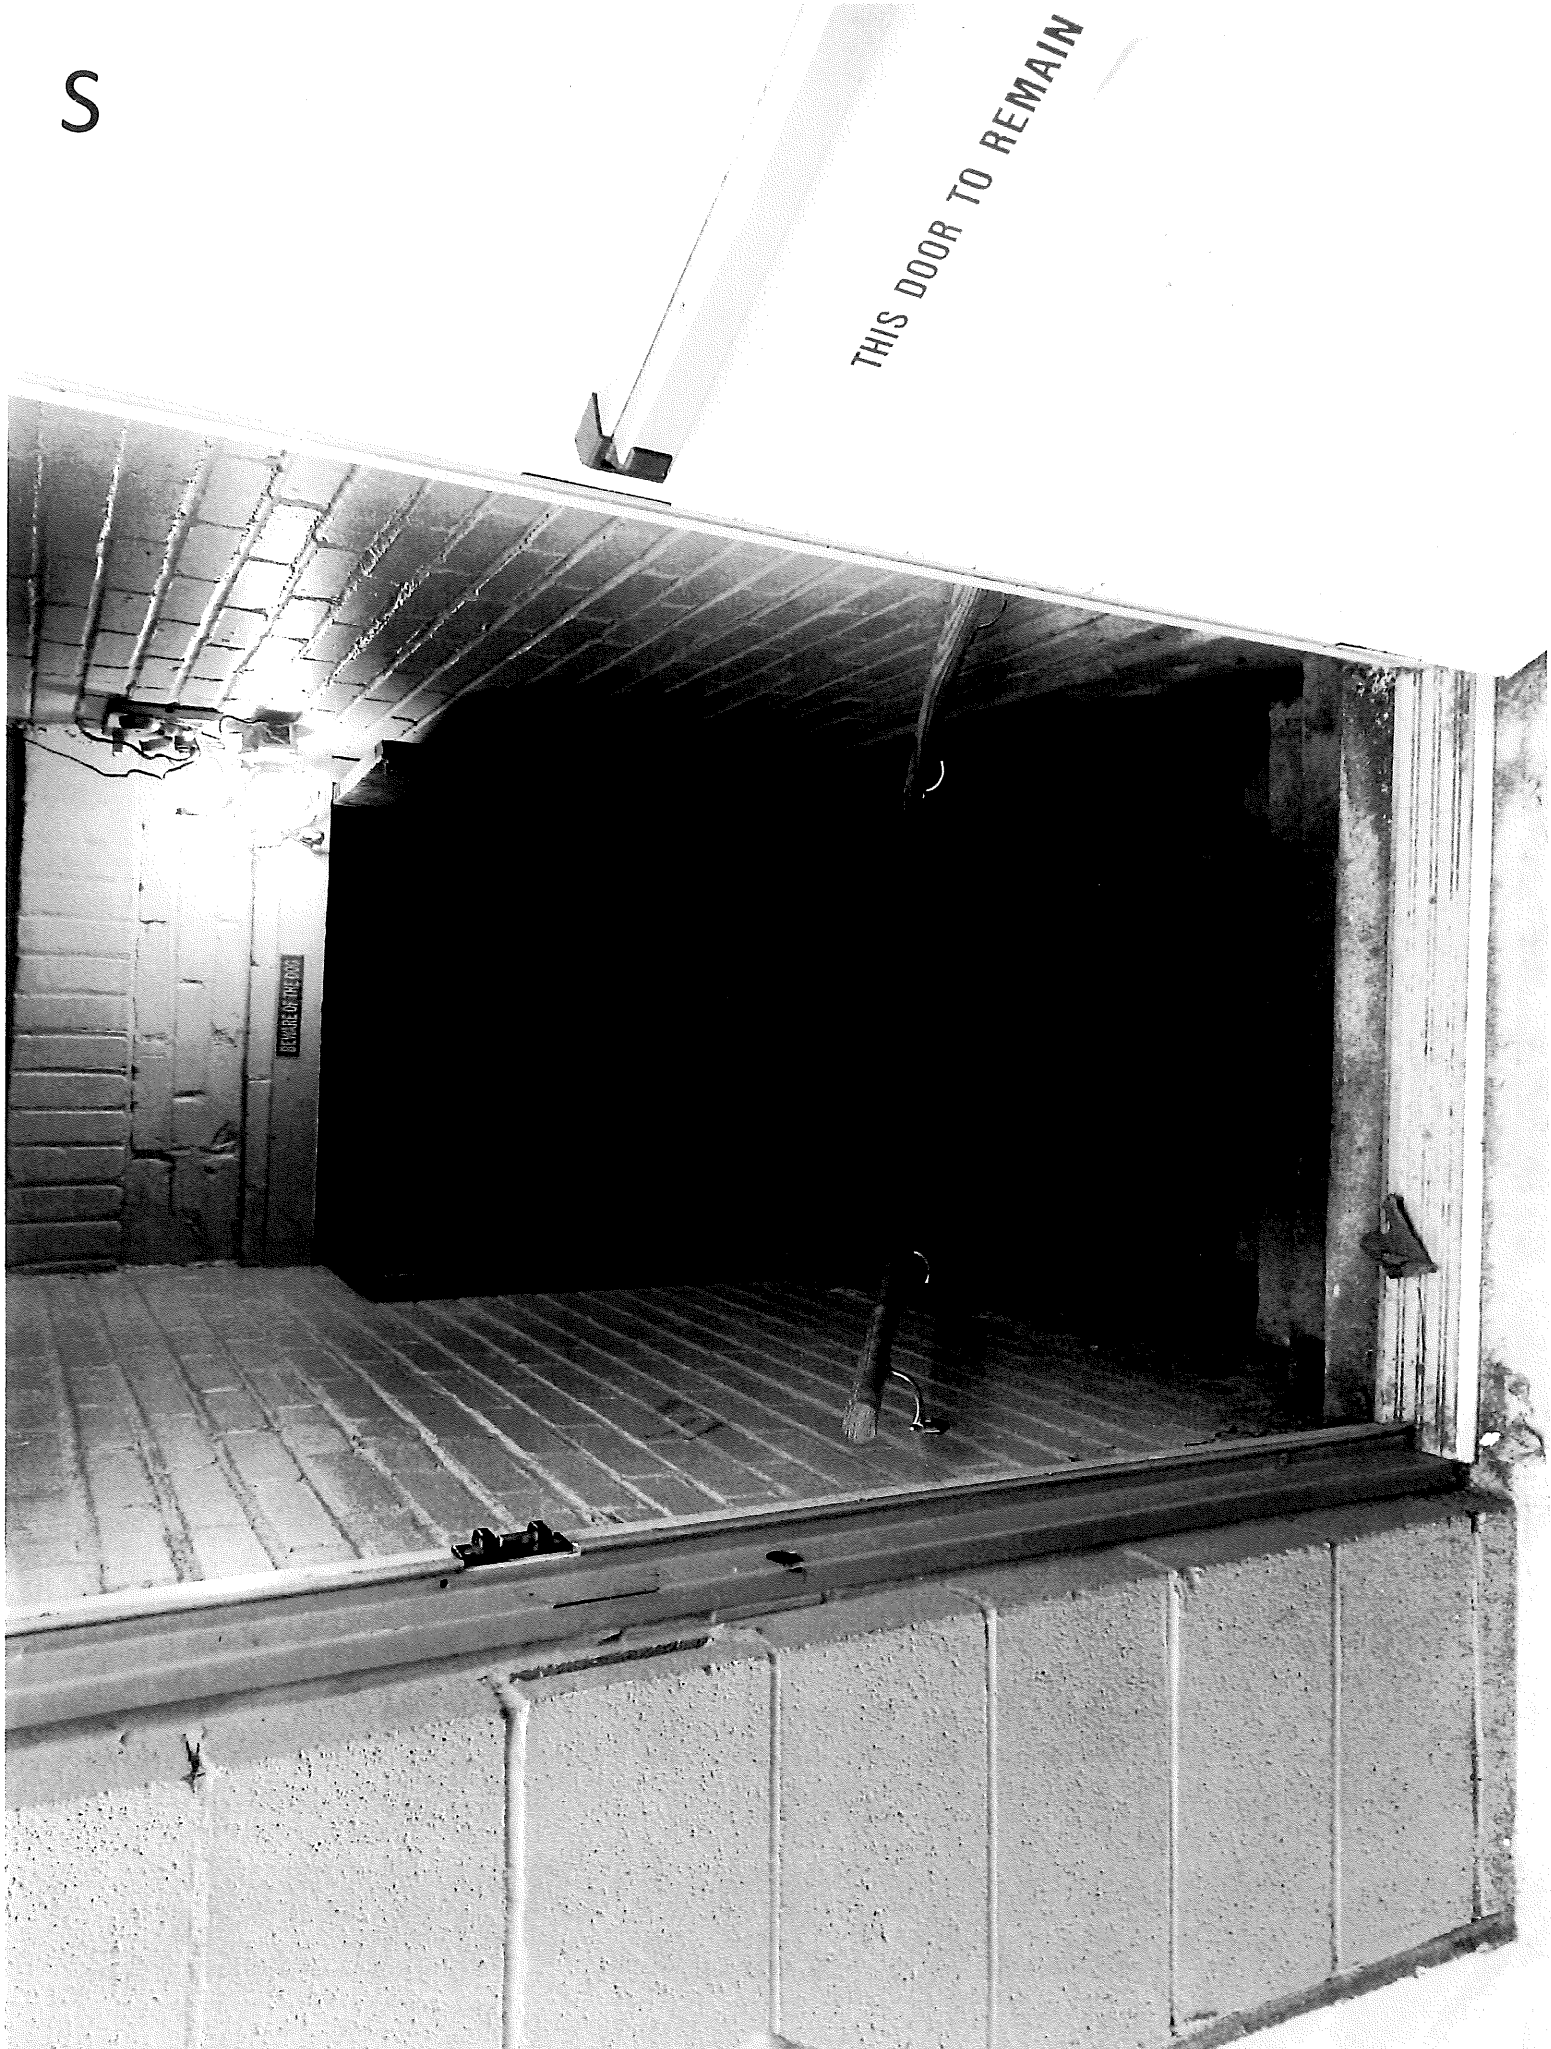
Exhibit S is at the top of the stairs looking into the lower level. This exit discharge is not illuminated at all times and requires a switch to turn the light on. There is no emergency lighting on the staircase or the exit discharge. Sections 1006.1 & 1006.3
