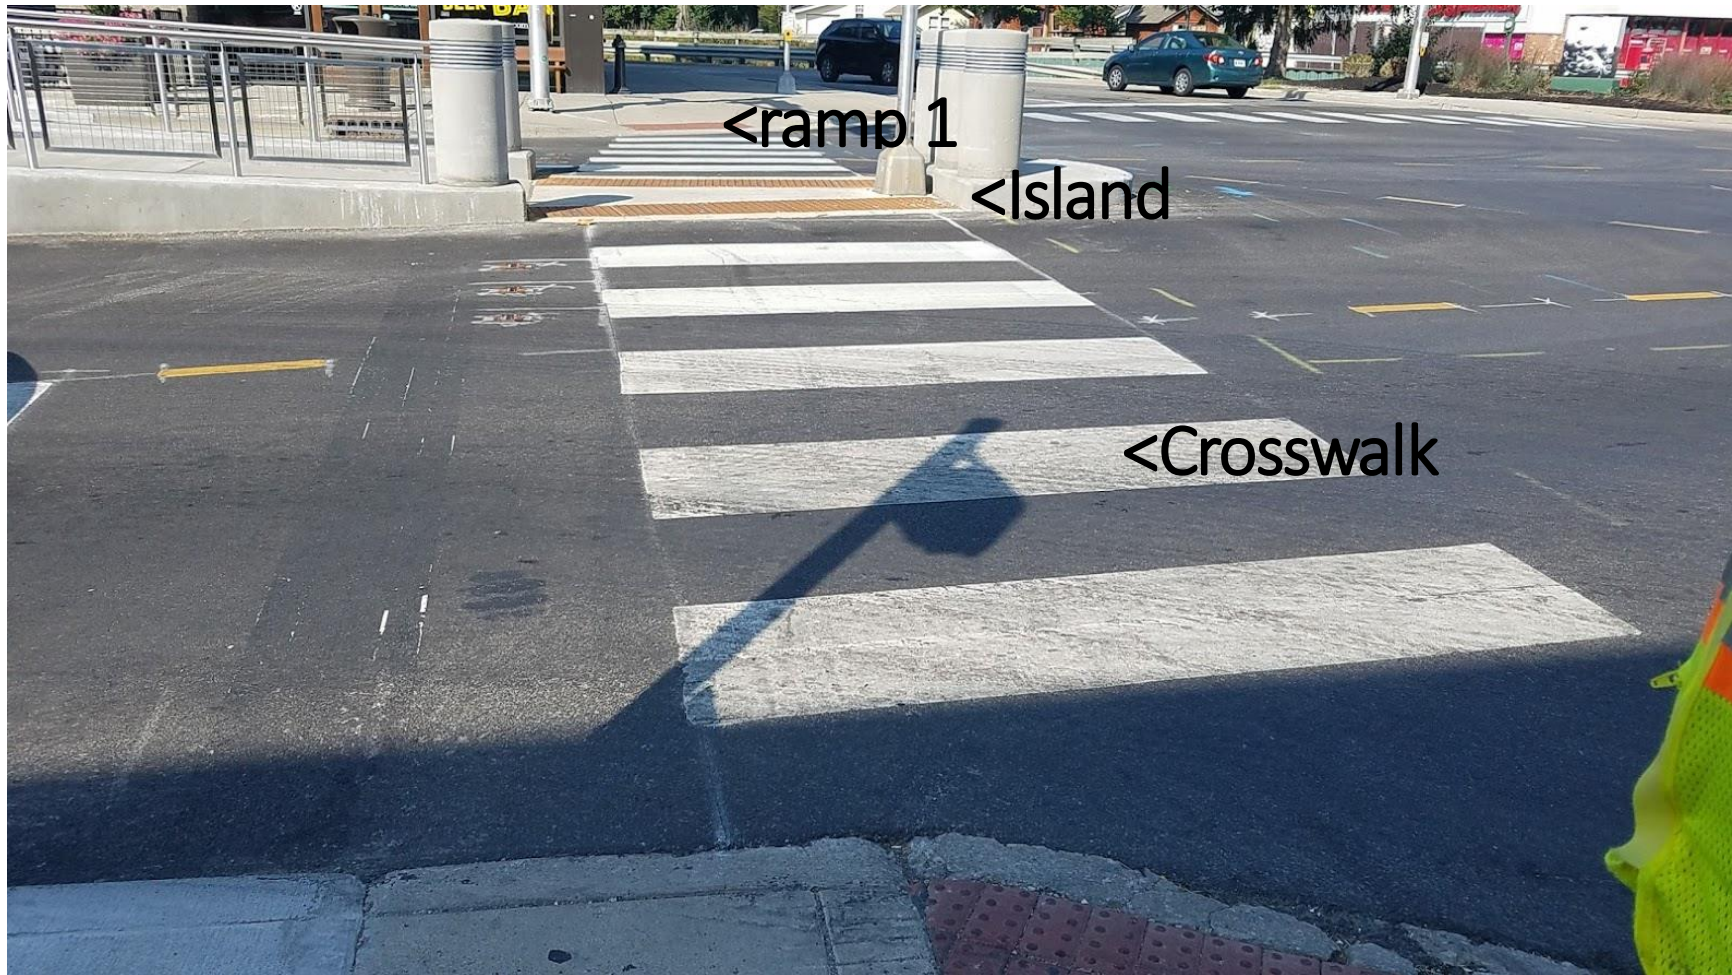
Street 1	Ramp 1 width	Ramp 1 slope	Ramp 1 cross slope	Ramp 1 DWS / transition	Ramp 1 type	Signal button type	Signal button reach	Signal Button height	Signal button size
Street 2									
Main Street	5 feet	5%	1.8%	level	perpendicular	APS	9.8"	41"	2"
Town Station	Crosswalk width	Crosswalk slope	Crosswalk cross slope	Crosswalk DWS / transition	Island type	Signal button type	Signal button reach	Signal Button height	Signal button size
	5 feet	5% / road grade	2%	level	Refugee	No button	n/a	n/a	n/a
	Sidewalk Width / slope	Sidewalk obstructions / pinch points	Near Transit? (within 0.5 mile)	Near School? (within 0.5 mile)	Near Hospital? (within 0.5 mile)	Near Gov't? (within 0.5 mile)	Near Soc. Services? (within 0.5 mile)	Near Park? (within 0.5 mile)	Complaints? (number)
	>5 feet / <2%	4" @ hydrant	Yes	No	No	No	No	Yes	0
Comments / Notes:									
Island contains a transit stop (bus rapid transit) Station is in ADA compliance and maintained as a separate asset. Pavement is in good condition.

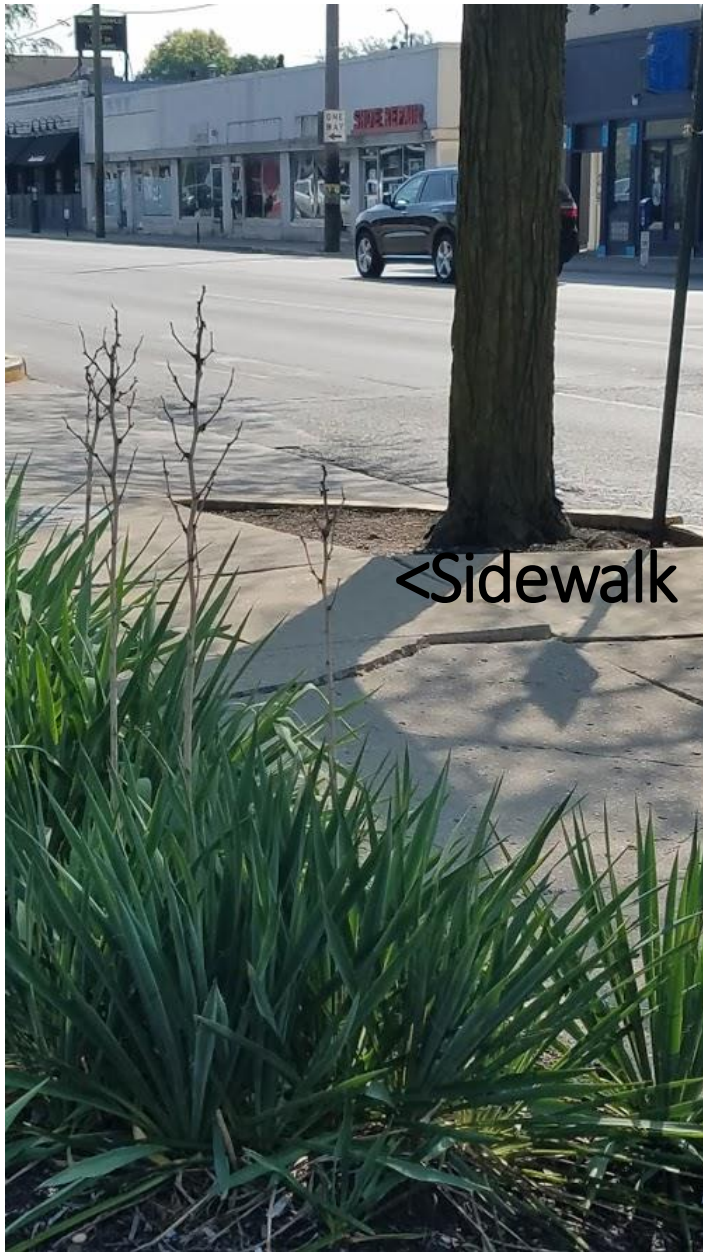
Street 1	Ramp 1 width	Ramp 1 slope	Ramp 1 cross slope	Ramp 1 DWS / transition	Ramp 1 type	Signal button type	Signal button reach	Signal Button height	Signal button size
Street 2									
Town Station	n/a	n/a	n/a	n/a	n/a	n/a	n/a	n/a	n/a
Main Street	Ramp 2 width	Ramp 2 slope	Ramp 2 cross slope	Ramp 2 DWS / transition	Ramp 2 type	Signal button type	Signal button reach	Signal Button height	Signal button size
	n/a	n/a	n/a	n/a	n/a	n/a	n/a	n/a	n/a
	Sidewalk Width / slope	Sidewalk obstructions / pinch points	Near Transit? (within 0.5 mile)	Near School? (within 0.5 mile)	Near Hospital? (within 0.5 mile)	Near Gov't? (within 0.5 mile)	Near Soc. Services? (within 0.5 mile)	Near Park? (within 0.5 mile)	Complaints? (number)
	3 feet	Heaving >1"	yes	no	no	no	no	yes	1
Comments / Notes:									
Sidewalk has cracked and heaved to create a 1.8" discontinuity within the pedestrian access route (PAR). Citizen called to inform maintenance of the issue after tripping over it a month ago.

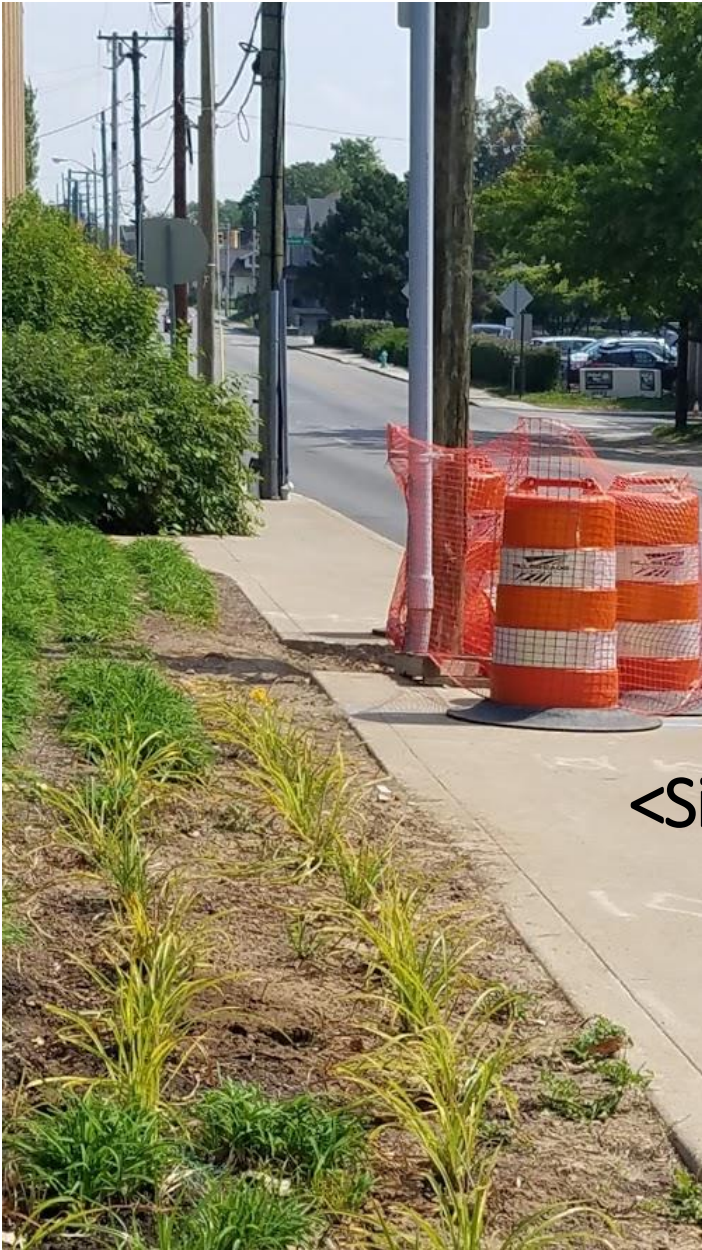
Street 1	Ramp 1 width	Ramp 1 slope	Ramp 1 cross slope	Ramp 1 DWS / transition	Ramp 1 type	Signal button type	Signal button reach	Signal Button height	Signal button size
Street 2	Ramp 2 width	Ramp 2 slope	Ramp 2 cross slope	Ramp 2 DWS / transition	Ramp 2 type	Signal button type	Signal button reach	Signal Button height	Signal button size
E Rainy Boulevard	n/a	n/a	n/a	n/a	n/a	n/a	n/a	n/a	n/a
Main street	Ramp 2 width	Ramp 2 slope	Ramp 2 cross slope	Ramp 2 DWS / transition	Ramp 2 type	Signal button type	Signal button reach	Signal Button height	Signal button size
	n/a	n/a	n/a	n/a	n/a	n/a	n/a	n/a	n/a
	Sidewalk Width / slope	Sidewalk obstructions / pinch points	Near Transit? (within 0.5 mile)	Near School? (within 0.5 mile)	Near Hospital? (within 0.5 mile)	Near Gov't? (within 0.5 mile)	Near Soc. Services? (within 0.5 mile)	Near Park? (within 0.5 mile)	Complaints? (number)
	38" @ 1.6%	Poles restrict to < 24"	yes	yes	no	yes	yes	no	0

Comments / Notes:									
Pavement removed by utility company for underground utility installation. No detour in place. Existing poles along entire block (actually corridor for more than 0.5 mile) restrict width of sidewalk to < 24"

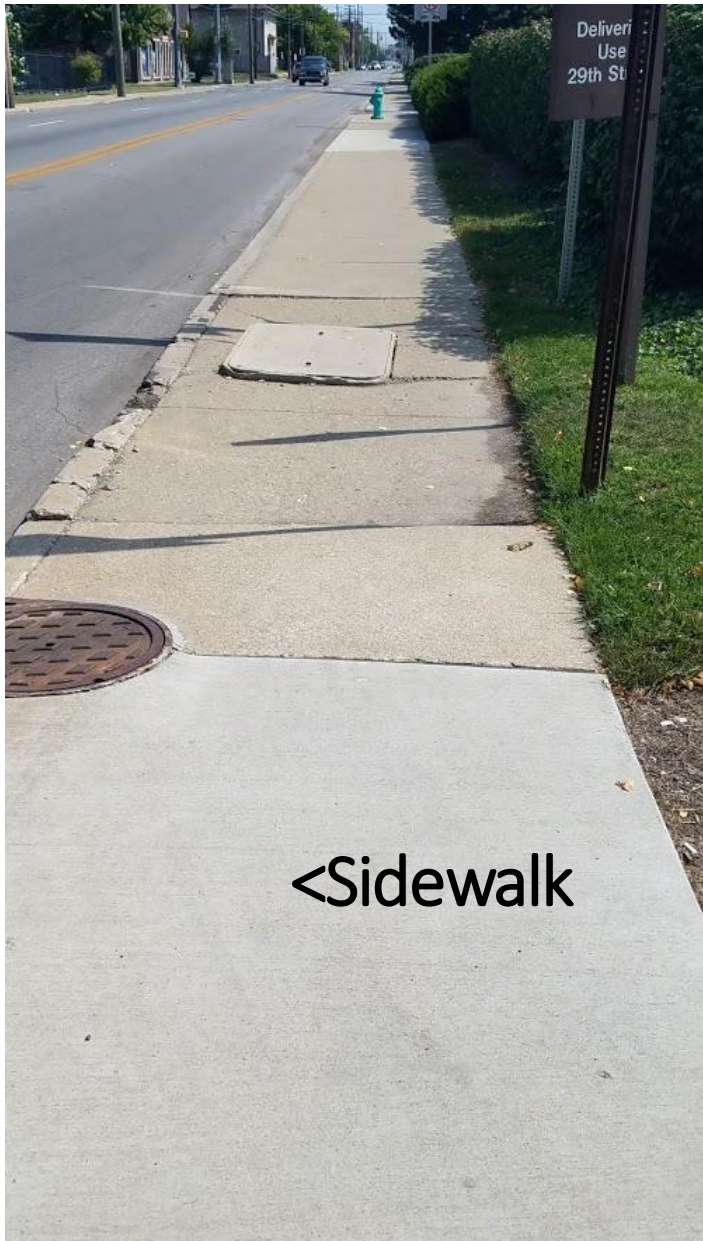
Street 1	Ramp 1 width	Ramp 1 slope	Ramp 1 cross slope	Ramp 1 DWS / transition	Ramp 1 type	Signal button type	Signal button reach	Signal Button height	Signal button size
Street 2									
West Rainy Boulevard	n/a	n/a	n/a	n/a	n/a	n/a	n/a	n/a	n/a
Main Street	Ramp 2 width	Ramp 2 slope	Ramp 2 cross slope	Ramp 2 DWS / transition	Ramp 2 type	Signal button type	Signal button reach	Signal Button height	Signal button size
	n/a	n/a	n/a	n/a	n/a	n/a	n/a	n/a	n/a
	Sidewalk Width / slope	Sidewalk obstructions / pinch points	Near Transit? (within 0.5 mile)	Near School? (within 0.5 mile)	Near Hospital? (within 0.5 mile)	Near Gov't? (within 0.5 mile)	Near Soc. Services? (within 0.5 mile)	Near Park? (within 0.5 mile)	Complaints? (number)
	5 feet	Utility casing > 1.5", cracks	yes	yes	no	yes	yes	no	0
Comments / Notes:									
Sidewalk is in disrepair with cracking / heaving creating > 1.5" discontinuities. Utility casing is elevated up to 1.8". Less than 2 feet around casing for passing space. Hydrant in sidewalk restricts to 29" on the right of hydrant. Remainder of route is unrestricted and ramps are compliance along route to 0.5 mile in each direction. Addressing this barrier will improve accessible route for up to 1 mile.

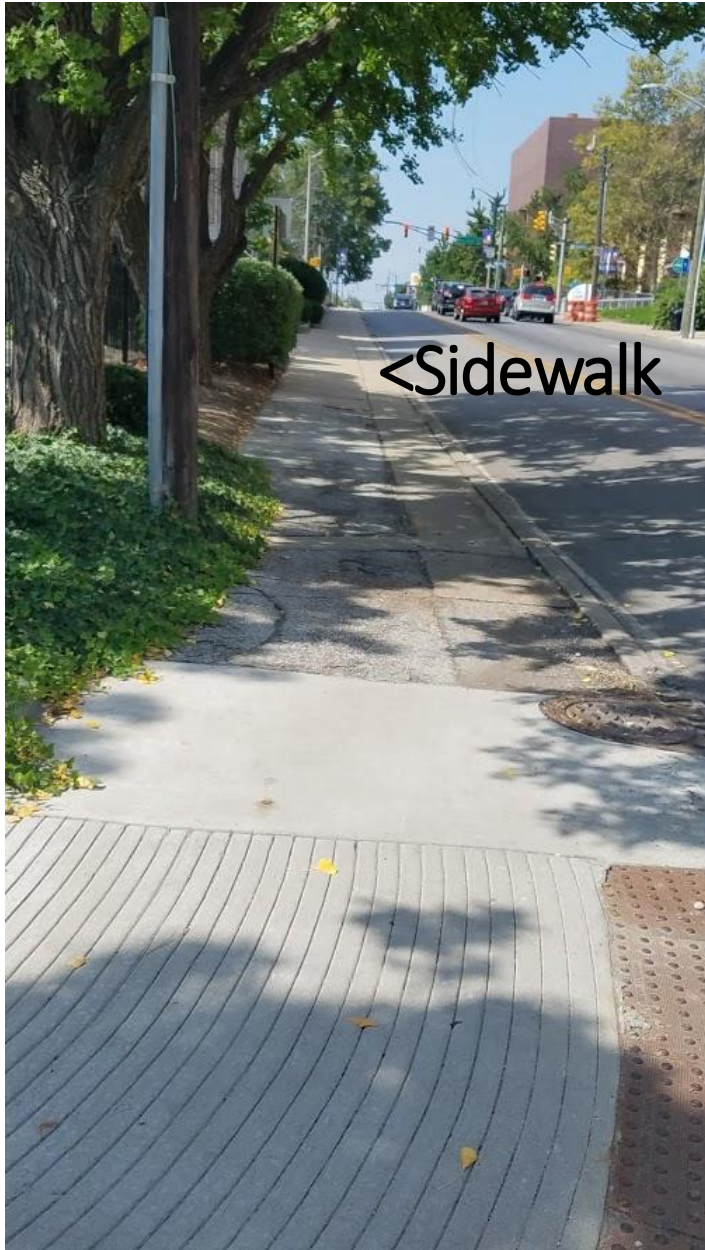
Street 1	Ramp 1 width	Ramp 1 slope	Ramp 1 cross slope	Ramp 1 DWS / transition	Ramp 1 type	Signal button type	Signal button reach	Signal Button height	Signal button size
Street 2									
E Bellevue St	n/a	n/a	n/a	n/a	n/a	n/a	n/a	n/a	n/a
Main street	Ramp 2 width	Ramp 2 slope	Ramp 2 cross slope	Ramp 2 DWS / transition	Ramp 2 type	Signal button type	Signal button reach	Signal Button height	Signal button size
	n/a	n/a	n/a	n/a	n/a	n/a	n/a	n/a	n/a
	Sidewalk Width / slope	Sidewalk obstructions / pinch points	Near Transit? (within 0.5 mile)	Near School? (within 0.5 mile)	Near Hospital? (within 0.5 mile)	Near Gov't? (within 0.5 mile)	Near Soc. Services? (within 0.5 mile)	Near Park? (within 0.5 mile)	Complaints? (number)
	5 feet	Cracked / sinking in middle	yes	yes	yes	yes	yes	no	1
Comments / Notes:									
Sidewalk is cracked and sloping toward the middle > 2% in each direction for 150 feet adjacent to curb ramp. Citizen complained 3 years ago when the ramp was put in that we addressed the ramp but didn't fix the sidewalk. Was not an ADA complaint but a general grievance. Additional barriers exist at each block in each direction of travel for > 0.5 mile. Other side of the street has been repaved for 2 miles and contains no barriers.

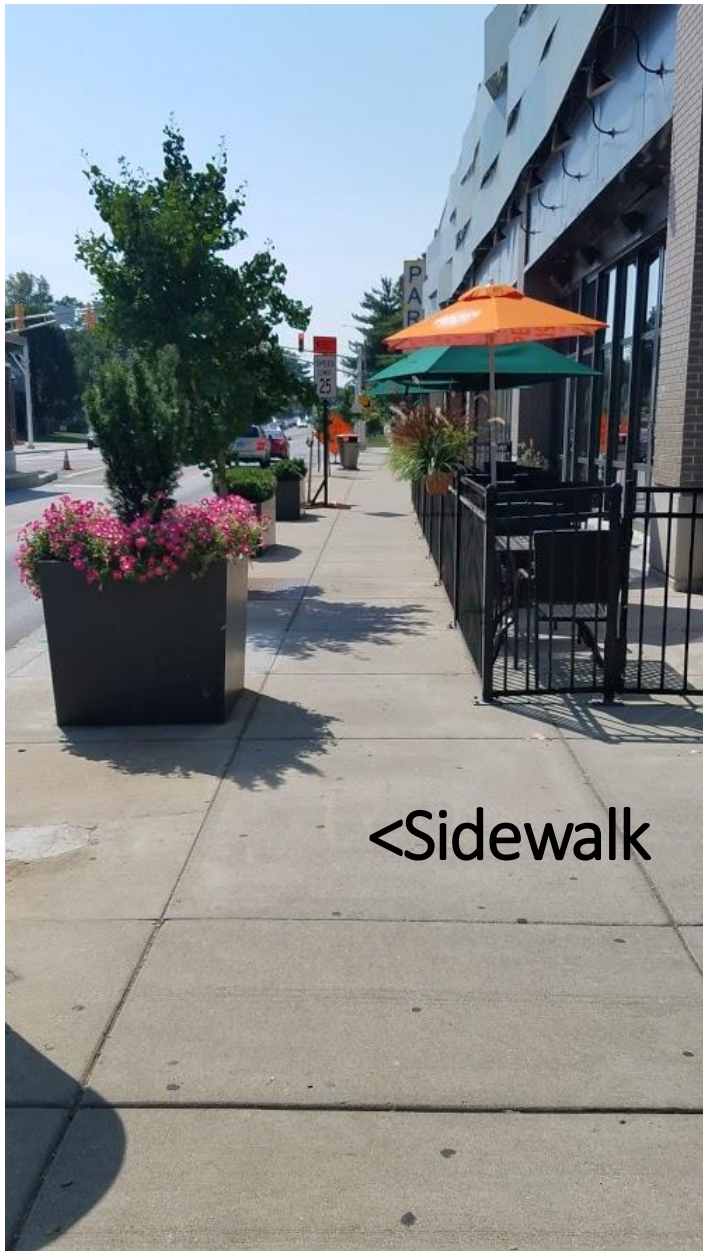
Street 1	Ramp 1 width	Ramp 1 slope	Ramp 1 cross slope	Ramp 1 DWS / transition	Ramp 1 type	Signal button type	Signal button reach	Signal Button height	Signal button size
Street 2									
Main Street	n/a	n/a	n/a	n/a	n/a	n/a	n/a	n/a	n/a
Town Station	Ramp 2 width	Ramp 2 slope	Ramp 2 cross slope	Ramp 2 DWS / transition	Ramp 2 type	Signal button type	Signal button reach	Signal Button height	Signal button size
	n/a	n/a	n/a	n/a	n/a	n/a	n/a	n/a	n/a
	Sidewalk Width / slope	Sidewalk obstructions / pinch points	Near Transit? (within 0.5 mile)	Near School? (within 0.5 mile)	Near Hospital? (within 0.5 mile)	Near Gov't? (within 0.5 mile)	Near Soc. Services? (within 0.5 mile)	Near Park? (within 0.5 mile)	Complaints? (number)
	12 feet @ 1.6% cross slope	Plants / fence & protruding objects restrict to 32"	Yes, at station	no	no	no	no	yes	0
Comments / Notes:									
Walkway at transit station restricted by fence and planters to 32". Removal of hanging baskets on fence would widen to 36", moving planters closer to curb would widen to 5 feet.

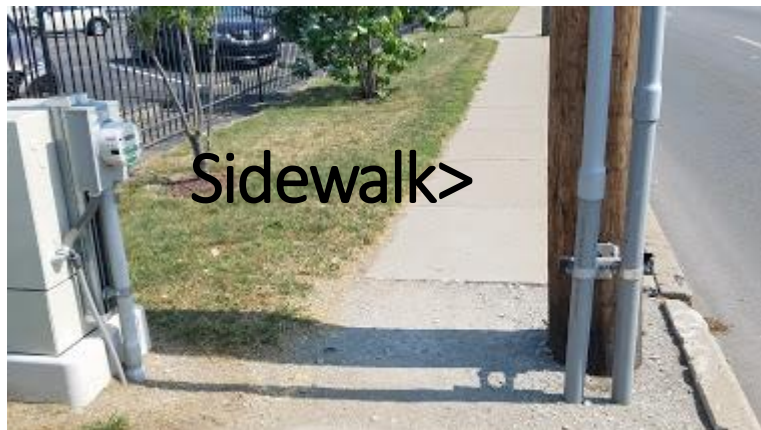
Street 1	Ramp 1 width	Ramp 1 slope	Ramp 1 cross slope	Ramp 1 DWS / transition	Ramp 1 type	Signal button type	Signal button reach	Signal Button height	Signal button size
Berkley Ave	n/a	n/a	n/a	n/a	n/a	n/a	n/a	n/a	n/a
Main Street	Ramp 2 width	Ramp 2 slope	Ramp 2 cross slope	Ramp 2 DWS / transition	Ramp 2 type	Signal button type	Signal button reach	Signal Button height	Signal button size
	n/a	n/a	n/a	n/a	n/a	n/a	n/a	n/a	n/a
	Sidewalk Width / slope	Sidewalk obstructions / pinch points	Near Transit? (within 0.5 mile)	Near School? (within 0.5 mile)	Near Hospital? (within 0.5 mile)	Near Gov't? (within 0.5 mile)	Near Soc. Services? (within 0.5 mile)	Near Park? (within 0.5 mile)	Complaints? (number)
	39" at 2% cross slope	Pole, pavement removed and replaced with gravel	yes	yes	yes	yes	yes	yes	1
Comments / Notes:									
Citizen called to complaint that power company did not replace paving when they installed unit across from their residence. Utility pole restricts access to < 28", this is the only pole restricting the route for 0.5 miles in each direction. Other poles have bump outs allocated. Discontinuity of > 1 " and unstable gravel surface where pavement has been removed.

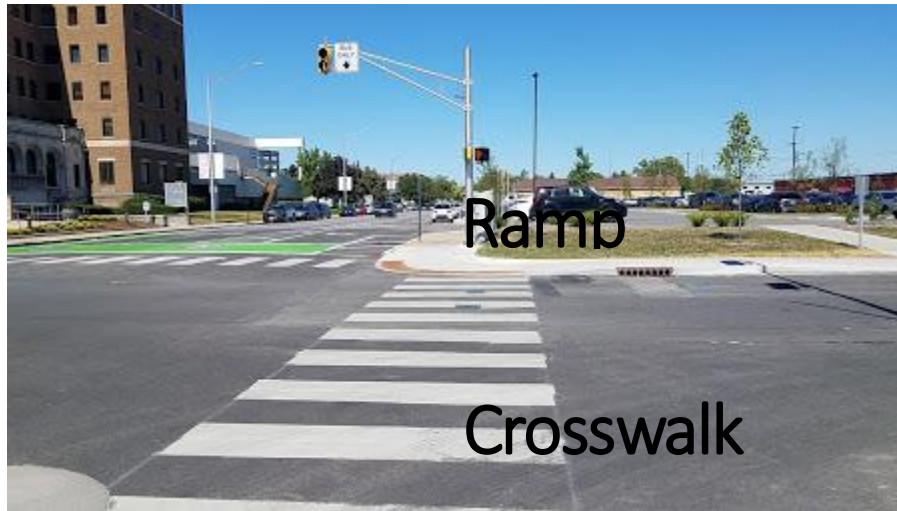
Street 1	Ramp 1 width	Ramp 1 slope	Ramp 1 cross slope	Ramp 1 DWS / transition	Ramp 1 type	Signal button type	Signal button reach	Signal Button height	Signal button size
Harley St.	6'	5.8%	Varies up to 5%	level	Blended Transition	None	n/a	n/a	n/a
Main Street	Ramp 2 width	Ramp 2 slope	Ramp 2 cross slope	Ramp 2 DWS / transition	Ramp 2 type	Signal button type	Signal button reach	Signal Button height	Signal button size
	n/a	n/a	n/a	n/a	n/a	n/a	n/a	n/a	n/a
	Sidewalk Width / slope	Sidewalk obstructions / pinch points	Near Transit? (within 0.5 mile)	Near School? (within 0.5 mile)	Near Hospital? (within 0.5 mile)	Near Gov't? (within 0.5 mile)	Near Soc. Services? (within 0.5 mile)	Near Park? (within 0.5 mile)	Complaints? (number)
	6'	Sign restricts to 5'	yes	yes	yes	yes	yes	yes	0
Comments / Notes:									
New curb ramp and crosswalks put in with added bike lanes along Harley street crossing main street. One block from transit station.

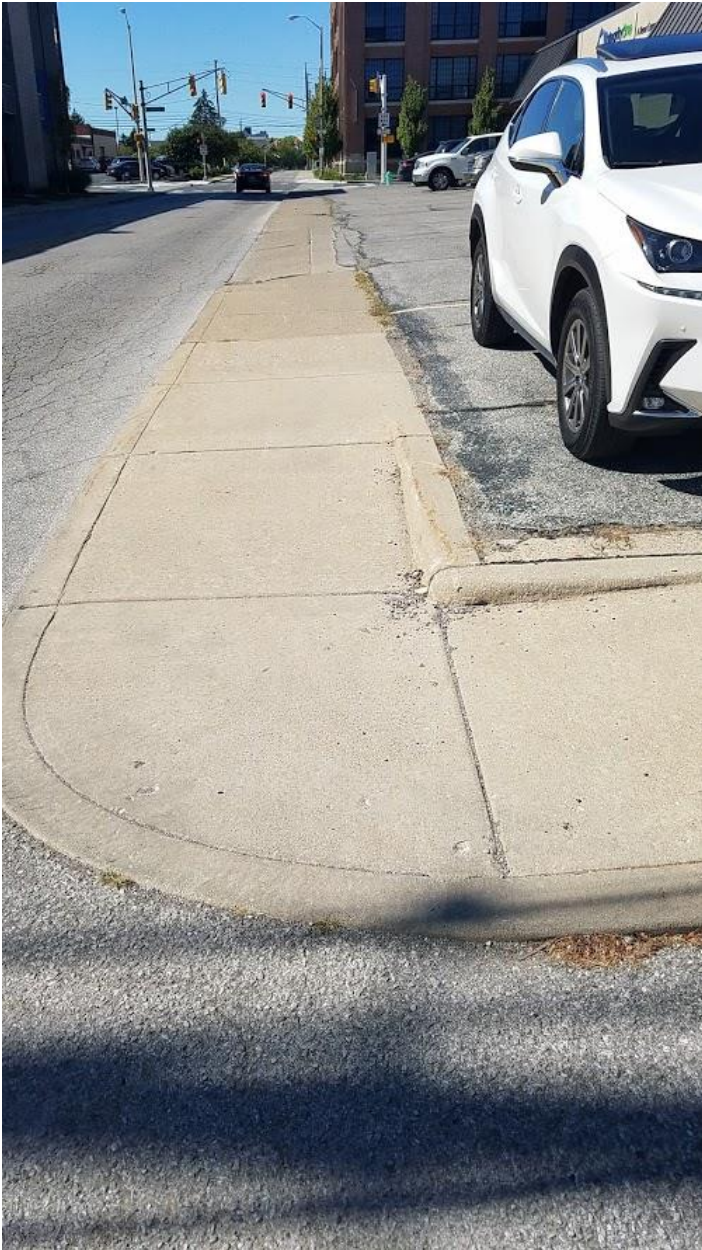
Street 1	Ramp 1 width	Ramp 1 slope	Ramp 1 cross slope	Ramp 1 DWS / transition	Ramp 1 type	Signal button type	Signal button reach	Signal Button height	Signal button size
Street 2									
Brighton St.	31"	4.6%	1.4%	none	Depressed corner	n/a	n/a	n/a	n/a
Park Way	Ramp 2 width	Ramp 2 slope	Ramp 2 cross slope	Ramp 2 DWS / transition	Ramp 2 type	Signal button type	Signal button reach	Signal Button height	Signal button size
	31"	5.1%	1.2%	none	Depressed Corner	n/a	n/a	n/a	n/a
	Sidewalk Width / slope	Sidewalk obstructions / pinch points	Near Transit? (within 0.5 mile)	Near School? (within 0.5 mile)	Near Hospital? (within 0.5 mile)	Near Gov't? (within 0.5 mile)	Near Soc. Services? (within 0.5 mile)	Near Park? (within 0.5 mile)	Complaints? (number)
	34"	Curb obstructs	yes	no	yes	yes	yes	no	0
Comments / Notes:									
2 blocks from hospital, 3 blocks from transit. Parking area for hospital and clinic is adjacent to this crossing.

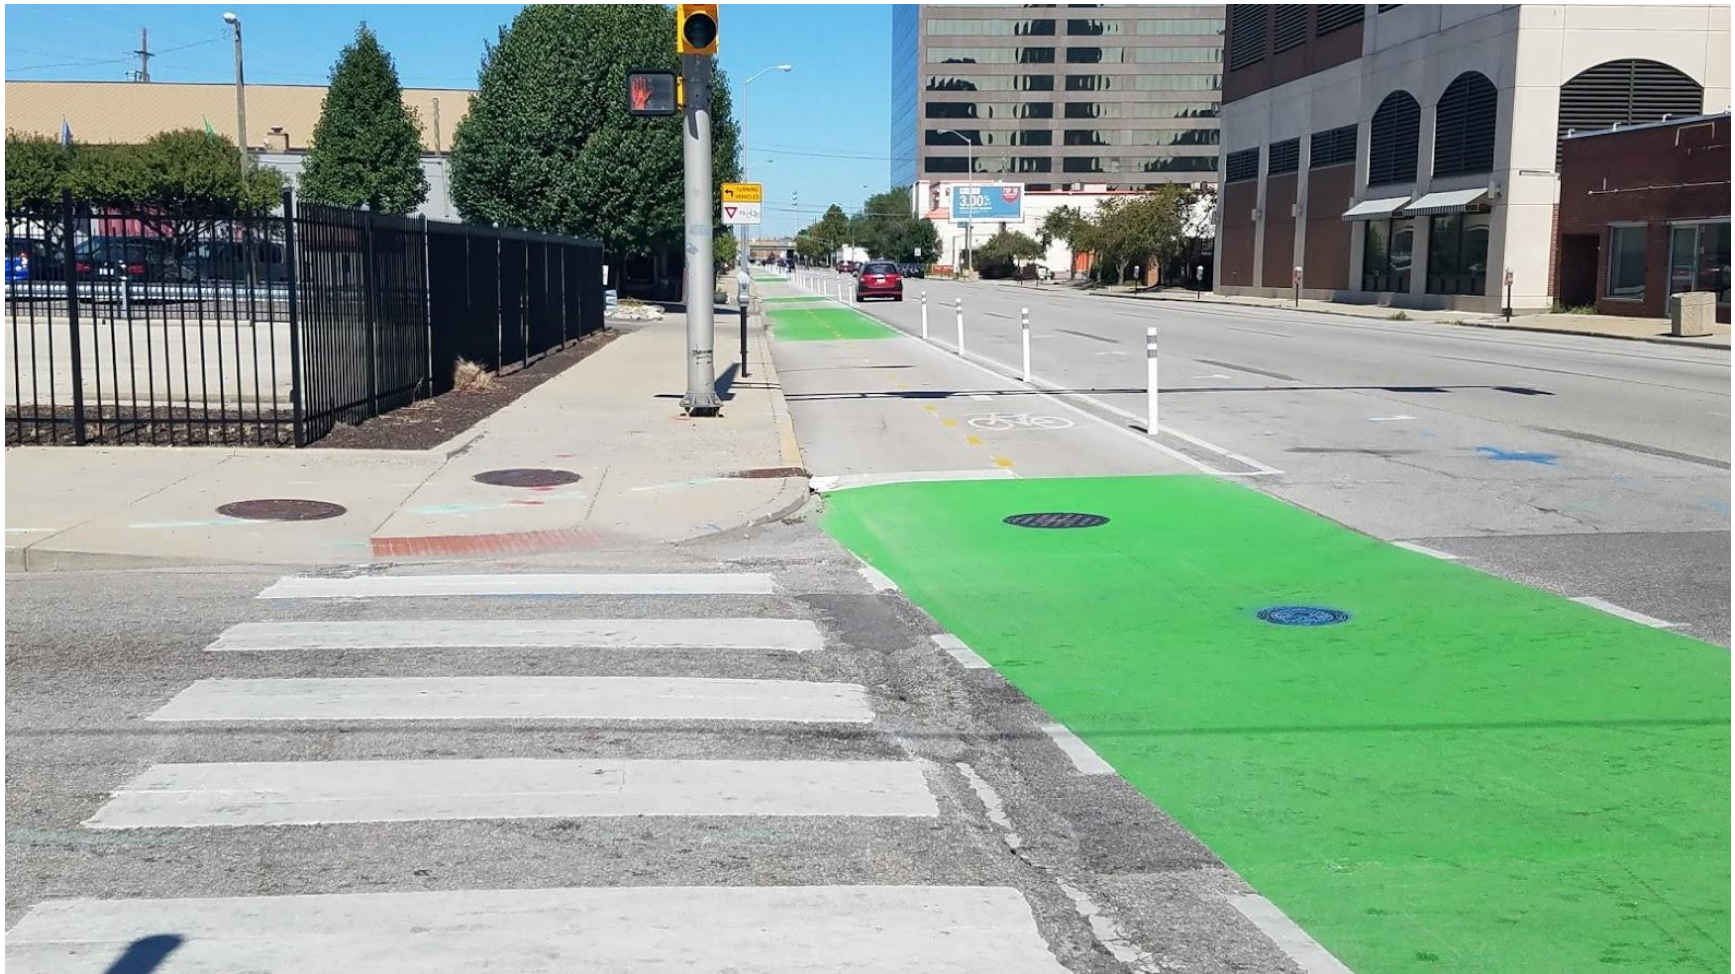
Street 1	Ramp 1 width	Ramp 1 slope	Ramp 1 cross slope	Ramp 1 DWS / transition	Ramp 1 type	Signal button type	Signal button reach	Signal Button height	Signal button size
Phoenix Street	4'	6.7%	2.8%	Flush, does not extend full width of flush area	Diagonal / depressed corner	n/a	n/a	n/a	n/a
Harley Ave.									
	Ramp 2 width	Ramp 2 slope	Ramp 2 cross slope	Ramp 2 DWS / transition	Ramp 2 type	Signal button type	Signal button reach	Signal Button height	Signal button size
	n/a	n/a	n/a	n/a	n/a	n/a	n/a	n/a	n/a
	Sidewalk Width / slope	Sidewalk obstructions / pinch points	Near Transit? (within 0.5 mile)	Near School? (within 0.5 mile)	Near Hospital? (within 0.5 mile)	Near Gov't? (within 0.5 mile)	Near Soc. Services? (within 0.5 mile)	Near Park? (within 0.5 mile)	Complaints? (number)
	6'	Yes, pole obstructs to 39"	yes	yes	yes	yes	yes	yes	2
Comments / Notes:									
2 complaints that it is unsafe to cross the street after bike lanes installed and general concern that bikes will ride on sidewalks. Ramp is collecting debris and holding water during rain events.

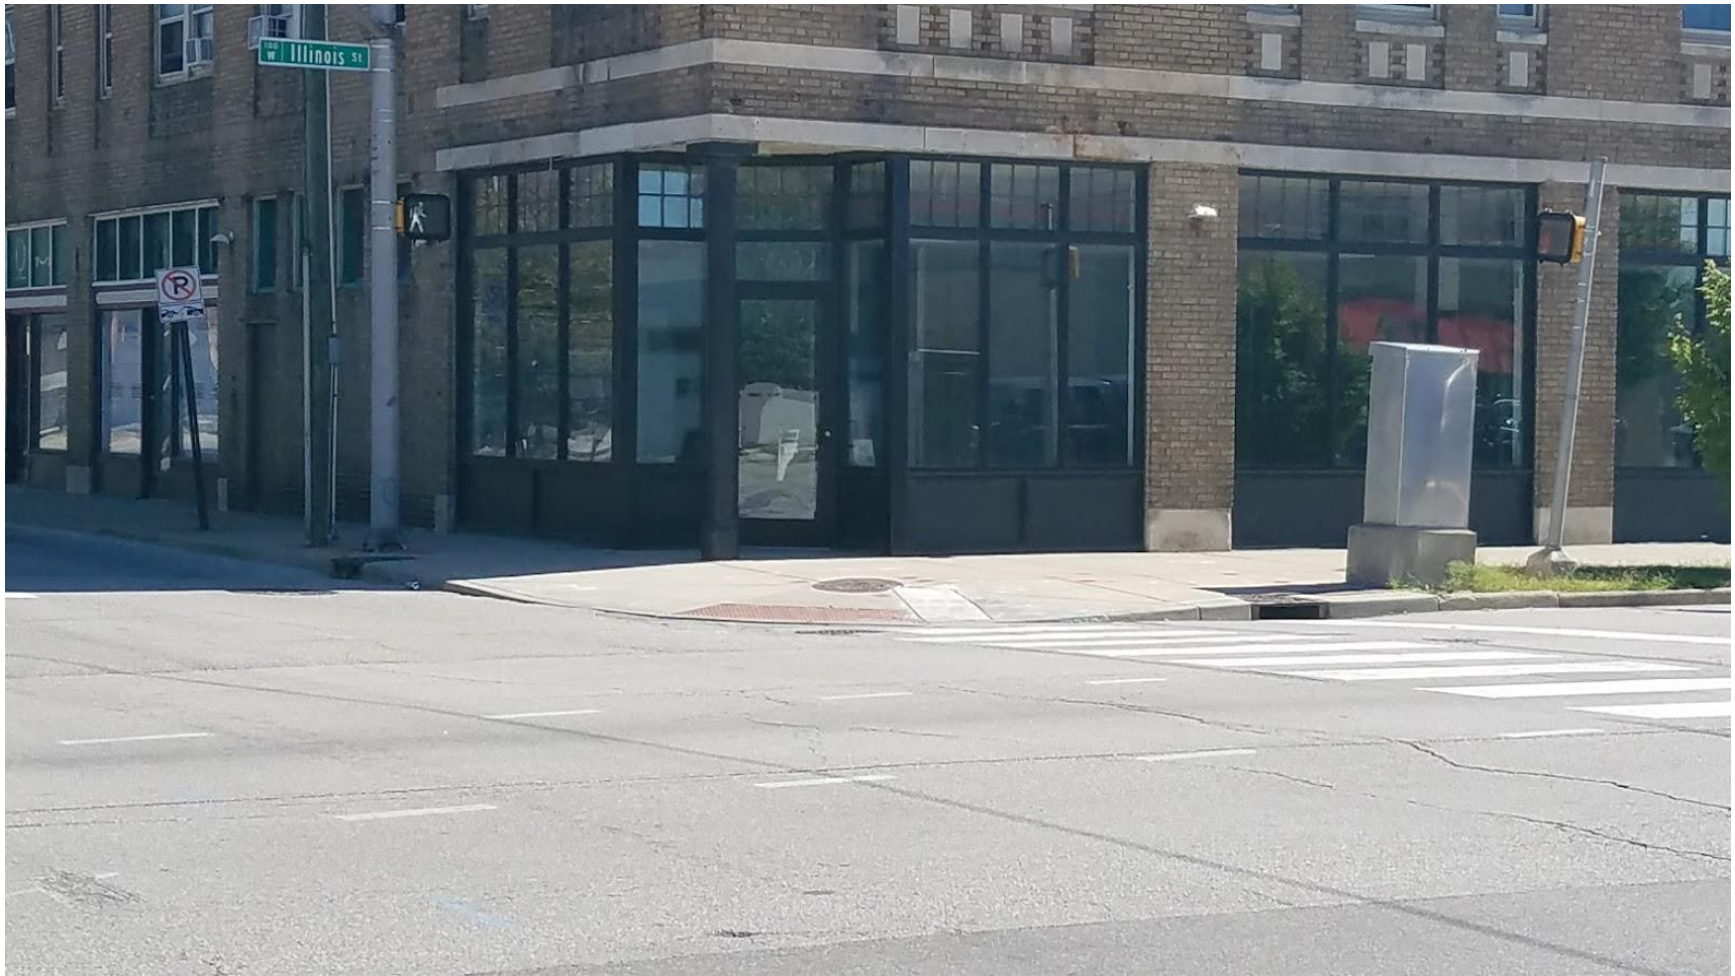
Street 1	Ramp 1 width	Ramp 1 slope	Ramp 1 cross slope	Ramp 1 DWS / transition	Ramp 1 type	Signal button type	Signal button reach	Signal Button height	Signal button size
Illinois	5'	7%	2.6%	Up to 0.75"	Depressed corner	none	n/a	n/a	n/a
Watson Street	Ramp 2 width	Ramp 2 slope	Ramp 2 cross slope	Ramp 2 DWS / transition	Ramp 2 type	Signal button type	Signal button reach	Signal Button height	Signal button size
	n/a	n/a	n/a	n/a	n/a	n/a	n/a	n/a	n/a
	Sidewalk Width / slope	Sidewalk obstructions / pinch points	Near Transit? (within 0.5 mile)	Near School? (within 0.5 mile)	Near Hospital? (within 0.5 mile)	Near Gov't? (within 0.5 mile)	Near Soc. Services? (within 0.5 mile)	Near Park? (within 0.5 mile)	Complaints? (number)
	8'	None	yes	no	yes	yes	yes	No	1
Comments / Notes:									
Ramp not contained within crosswalk. Disabled complainant concerned that he has to get to the bottom of the ramp in front of traffic before turning to cross street in crosswalk. He also believed the ramp was steep and a tipping hazard.

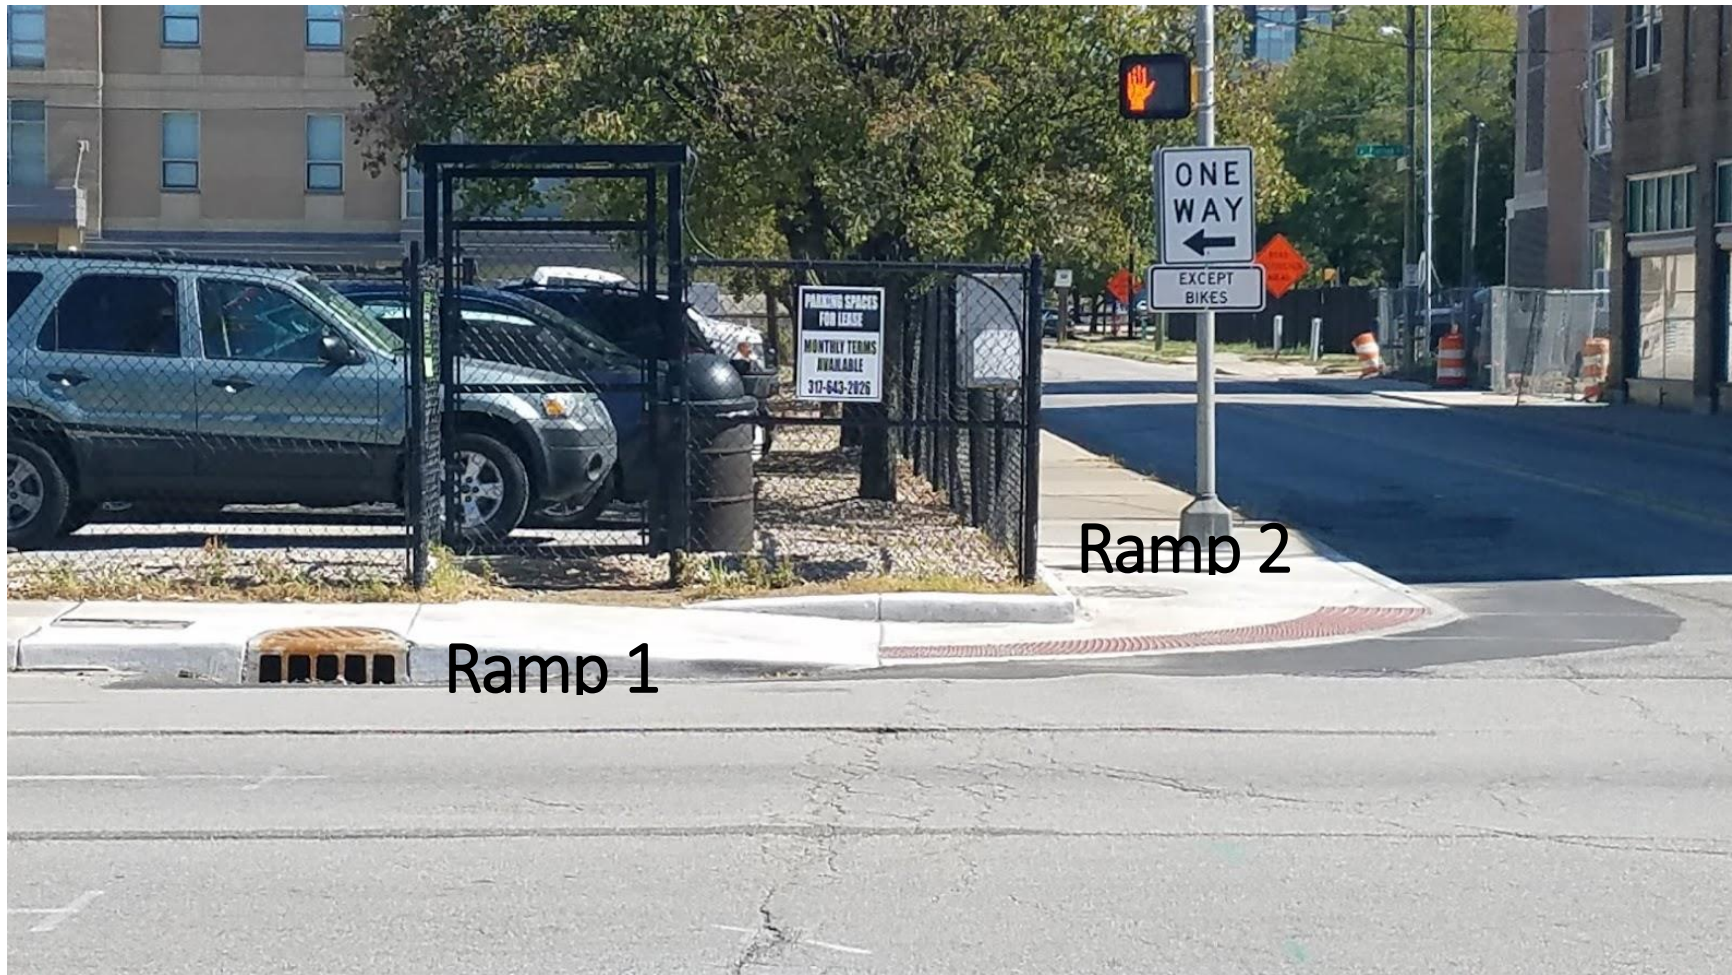
Street 1	Ramp 1 width	Ramp 1 slope	Ramp 1 cross slope	Ramp 1 DWS / transition	Ramp 1 type	Signal button type	Signal button reach	Signal Button height	Signal button size
Illinois	37"	8.45%	2.2%	flush	Blended transition	None	n/a	n/a	n/a
Sherman Street	Ramp 2 width	Ramp 2 slope	Ramp 2 cross slope	Ramp 2 DWS / transition	Ramp 2 type	Signal button type	Signal button reach	Signal Button height	Signal button size
	41"	1.6%	1.2%	flush	Blended transition	None	n/a	n/a	n/a
	Sidewalk Width / slope	Sidewalk obstructions / pinch points	Near Transit? (within 0.5 mile)	Near School? (within 0.5 mile)	Near Hospital? (within 0.5 mile)	Near Gov't? (within 0.5 mile)	Near Soc. Services? (within 0.5 mile)	Near Park? (within 0.5 mile)	Complaints? (number)
	42"	Pole, inlet	No	No	No	No	No	No	0
Comments / Notes:									
New ramp installed as part of drainage project along Sherman street. Pole obstructs to 28" and inlet to 21" although inlet top is traversable but does have >0.5" raised bumps. Detectable warning surface does not extend all the way around the ramp.

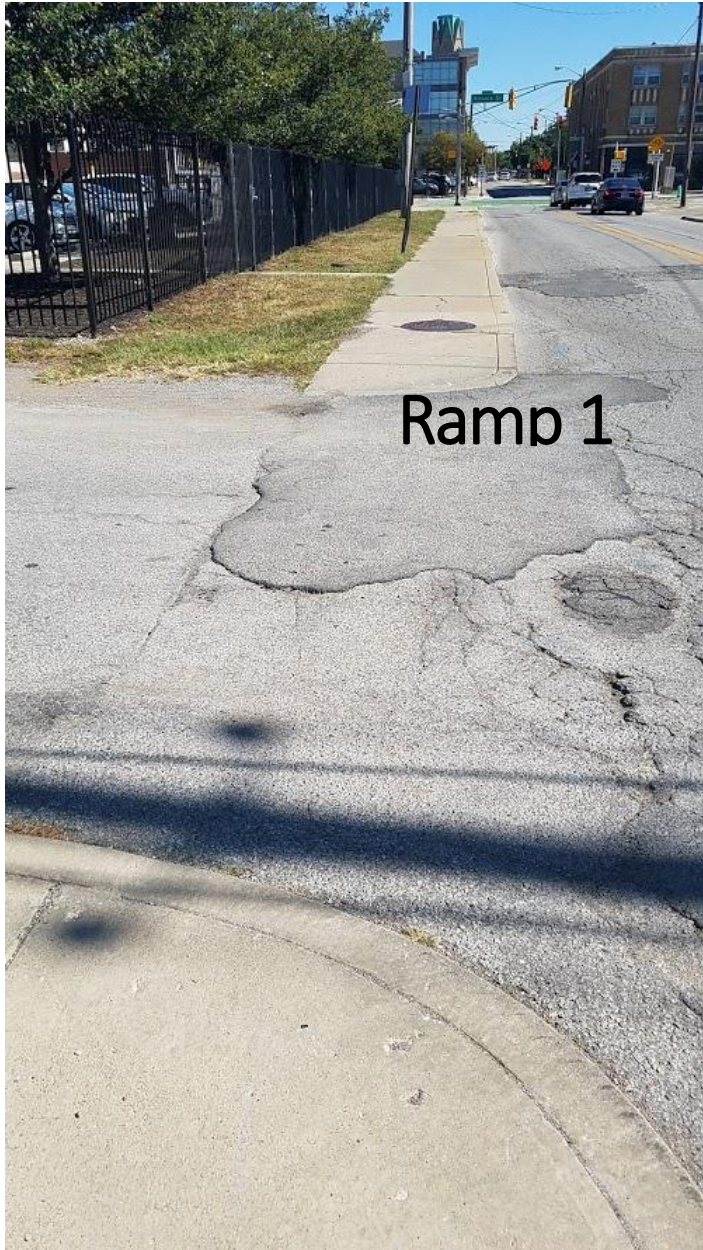
Street 1	Ramp 1 width	Ramp 1 slope	Ramp 1 cross slope	Ramp 1 DWS / transition	Ramp 1 type	Signal button type	Signal button reach	Signal Button height	Signal button size
Street 2	Ramp 2 width	Ramp 2 slope	Ramp 2 cross slope	Ramp 2 DWS / transition	Ramp 2 type	Signal button type	Signal button reach	Signal Button height	Signal button size
Perkins St. & Ralston Way Near Harley Ave.	42"	1.9%	0.4%	none	perpendicular	n/a	n/a	n/a	n/a
	Ramp 2 width	Ramp 2 slope	Ramp 2 cross slope	Ramp 2 DWS / transition	Ramp 2 type	Signal button type	Signal button reach	Signal Button height	Signal button size
	n/a	n/a	n/a	n/a	n/a	n/a	n/a	n/a	n/a
	Sidewalk Width / slope	Sidewalk obstructions / pinch points	Near Transit? (within 0.5 mile)	Near School? (within 0.5 mile)	Near Hospital? (within 0.5 mile)	Near Gov't? (within 0.5 mile)	Near Soc. Services? (within 0.5 mile)	Near Park? (within 0.5 mile)	Complaints? (number)
	42"	Manhole covers, flush	No	No	No	No	No	No	0

Comments / Notes:									
Perkins street half a block from the new bike lanes along Harley.

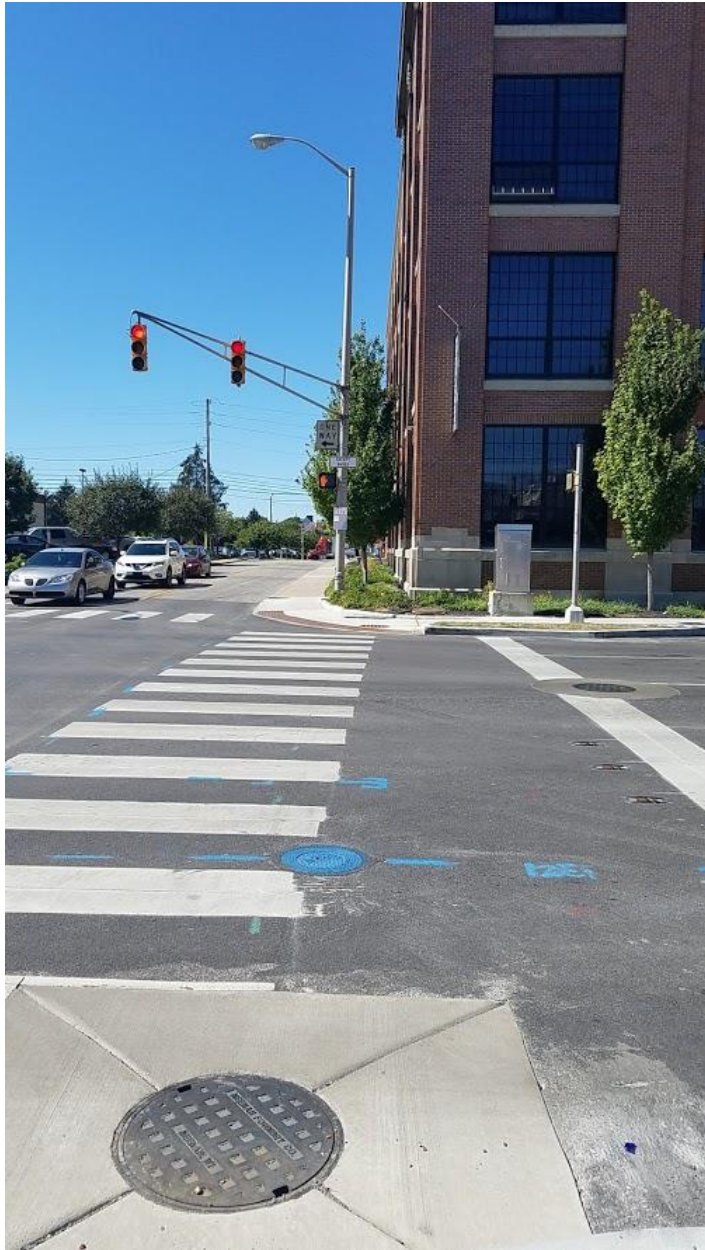
Street 1	Ramp 1 width	Ramp 1 slope	Ramp 1 cross slope	Ramp 1 DWS / transition	Ramp 1 type	Signal button type	Signal button reach	Signal Button height	Signal button size
Street 2									
Harper Street	5'	3.9%	Up to 2%	flush	Blended transition	None	n/a	n/a	n/a
Main Street	Ramp 2 width	Ramp 2 slope	Ramp 2 cross slope	Ramp 2 DWS / transition	Ramp 2 type	Signal button type	Signal button reach	Signal Button height	Signal button size
	n/a	n/a	n/a	n/a	n/a	n/a	n/a	n/a	n/a
	Sidewalk Width / slope	Sidewalk obstructions / pinch points	Near Transit? (within 0.5 mile)	Near School? (within 0.5 mile)	Near Hospital? (within 0.5 mile)	Near Gov't? (within 0.5 mile)	Near Soc. Services? (within 0.5 mile)	Near Park? (within 0.5 mile)	Complaints? (number)
	5'	None	Yes	Yes	Yes	Yes	Yes	Yes	0
Comments / Notes:									
New curb ramps along transit corridor.

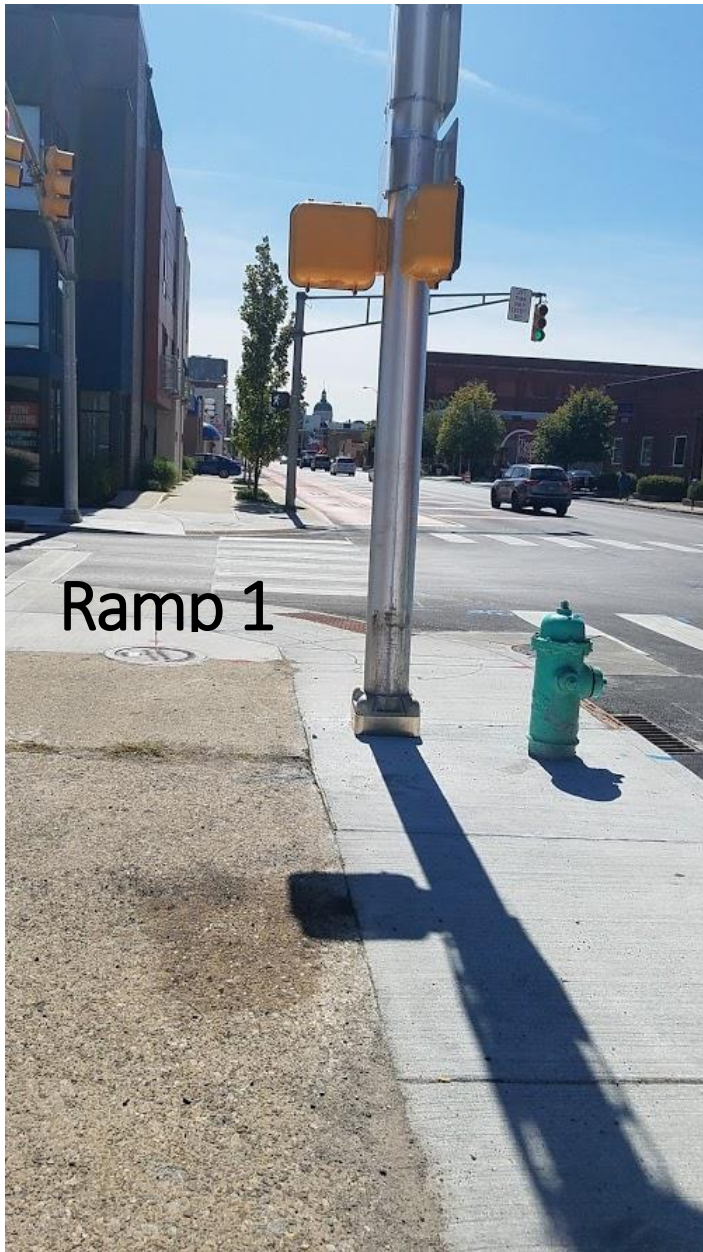
Street 1	Ramp 1 width	Ramp 1 slope	Ramp 1 cross slope	Ramp 1 DWS / transition	Ramp 1 type	Signal button type	Signal button reach	Signal Button height	Signal button size
Street 2									
Biloxi Street	48"	6%	2.3%	flush	Depressed corner	none	n/a	n/a	n/a
Main Street	Ramp 2 width	Ramp 2 slope	Ramp 2 cross slope	Ramp 2 DWS / transition	Ramp 2 type	Signal button type	Signal button reach	Signal Button height	Signal button size
	n/a	n/a	n/a	n/a	n/a	n/a	n/a	n/a	n/a
	Sidewalk Width / slope	Sidewalk obstructions / pinch points	Near Transit? (within 0.5 mile)	Near School? (within 0.5 mile)	Near Hospital? (within 0.5 mile)	Near Gov't? (within 0.5 mile)	Near Soc. Services? (within 0.5 mile)	Near Park? (within 0.5 mile)	Complaints? (number)
	5'	Yes, poles, hydrant	yes	yes	yes	yes	yes	yes	1
Comments / Notes:									
Disabled complainant that new sidewalks were placed without removing obstructions, even though complainant can navigate through adjacent flush parking lot to ramp so long as it is not obstructed by parked vehicles.

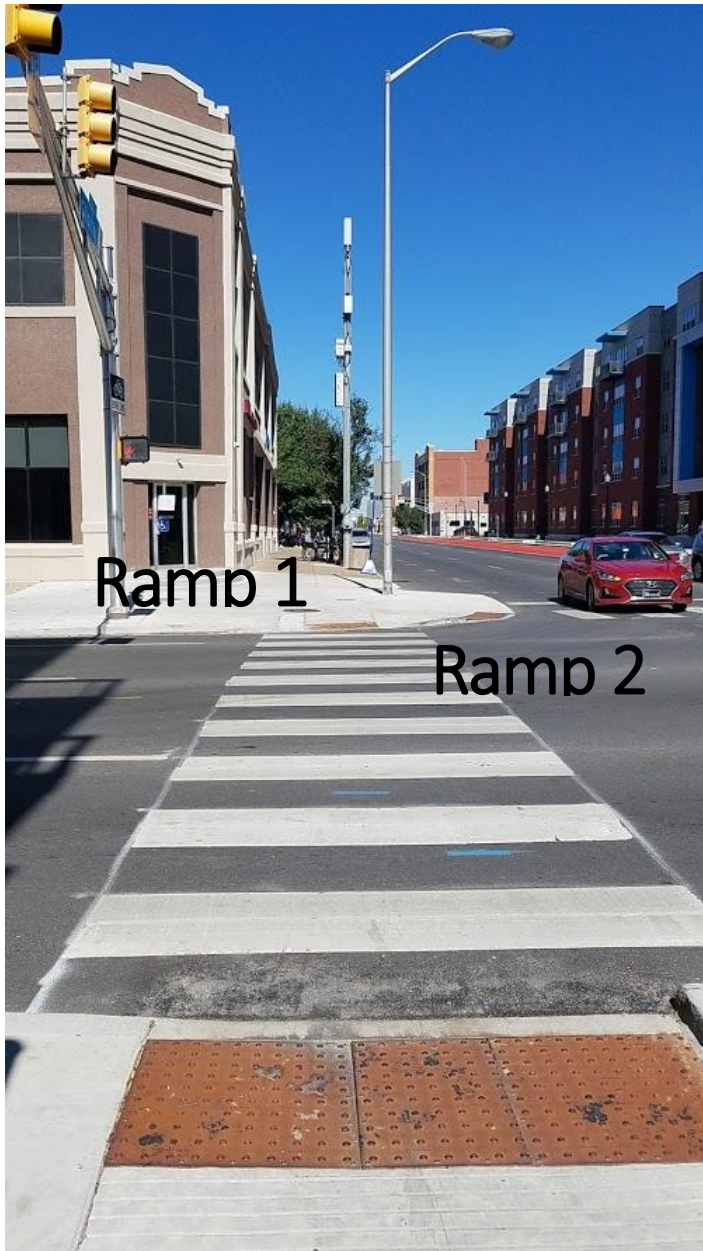
Street 1	Ramp 1 width	Ramp 1 slope	Ramp 1 cross slope	Ramp 1 DWS / transition	Ramp 1 type	Signal button type	Signal button reach	Signal Button height	Signal button size
Street 2	Ramp 2 width	Ramp 2 slope	Ramp 2 cross slope	Ramp 2 DWS / transition	Ramp 2 type	Signal button type	Signal button reach	Signal Button height	Signal button size
Brady Street Main Street	5'	6.7%	2.4%	Flush	Perpendicular	None	n/a	n/a	n/a
	Ramp 2 width	Ramp 2 slope	Ramp 2 cross slope	Ramp 2 DWS / transition	Ramp 2 type	Signal button type	Signal button reach	Signal Button height	Signal button size
	5'	7.3%	3.2%	flush	Perpendicular	None	n/a	n/a	n/a
	Sidewalk Width / slope	Sidewalk obstructions / pinch points	Near Transit? (within 0.5 mile)	Near School? (within 0.5 mile)	Near Hospital? (within 0.5 mile)	Near Gov't? (within 0.5 mile)	Near Soc. Services? (within 0.5 mile)	Near Park? (within 0.5 mile)	Complaints? (number)
	13'	none	yes	yes	yes	yes	yes	yes	0

Comments / Notes:									
New sidewalk and ramp construction near new grocery store along transit route.

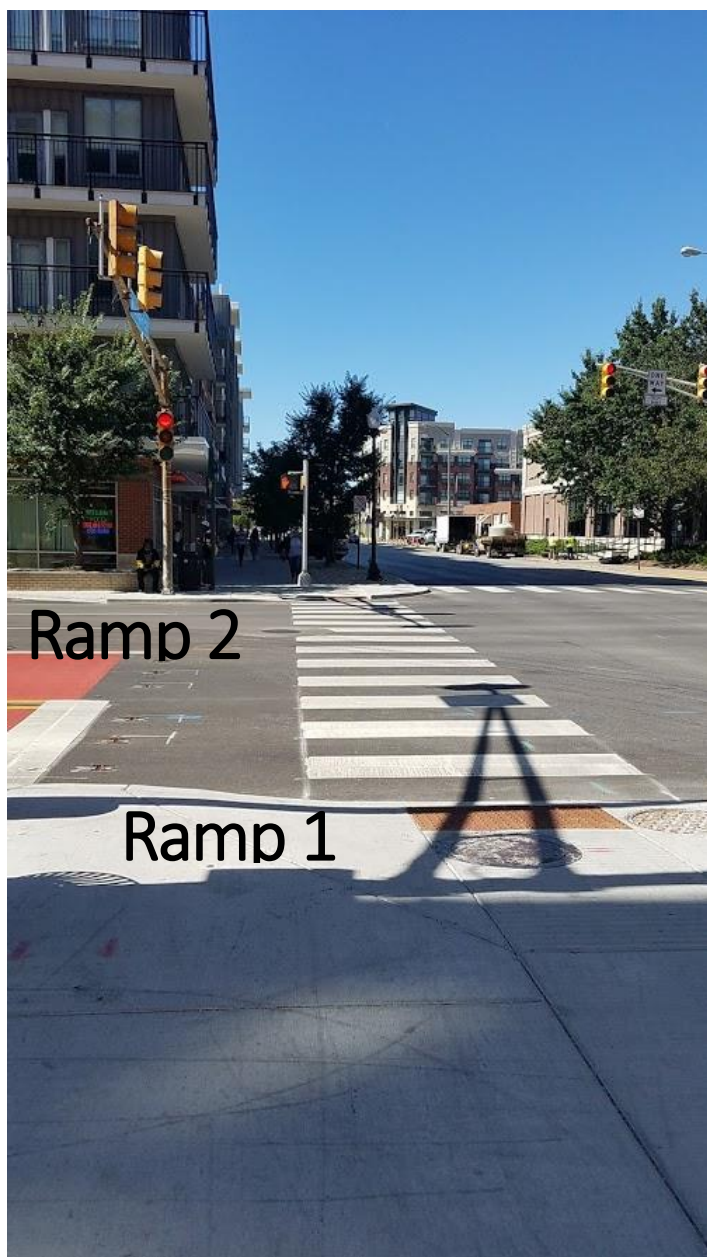
Street 1	Ramp 1 width	Ramp 1 slope	Ramp 1 cross slope	Ramp 1 DWS / transition	Ramp 1 type	Signal button type	Signal button reach	Signal Button height	Signal button size
Street 2									
Montgomery Main Street	3'	1.6%	1.2%	Flush, too narrow	perpendicular	None	n/a	n/a	n/a
	Ramp 2 width	Ramp 2 slope	Ramp 2 cross slope	Ramp 2 DWS / transition	Ramp 2 type	Signal button type	Signal button reach	Signal Button height	Signal button size
	4'	2%	0.6%	Flush	Perpendicular	None	n/a	n/a	n/a
	Sidewalk Width / slope	Sidewalk obstructions / pinch points	Near Transit? (within 0.5 mile)	Near School? (within 0.5 mile)	Near Hospital? (within 0.5 mile)	Near Gov't? (within 0.5 mile)	Near Soc. Services? (within 0.5 mile)	Near Park? (within 0.5 mile)	Complaints? (number)
	8' minimum 2% or less	Manhole in ramp	yes	yes	yes	yes	yes	yes	1
Comments / Notes:									
Disabled complainant let us know that water is collecting in our new ramp. She also pointed out that the detectable warning surface was 3" shy of covering the entire ramp where it met the street.
