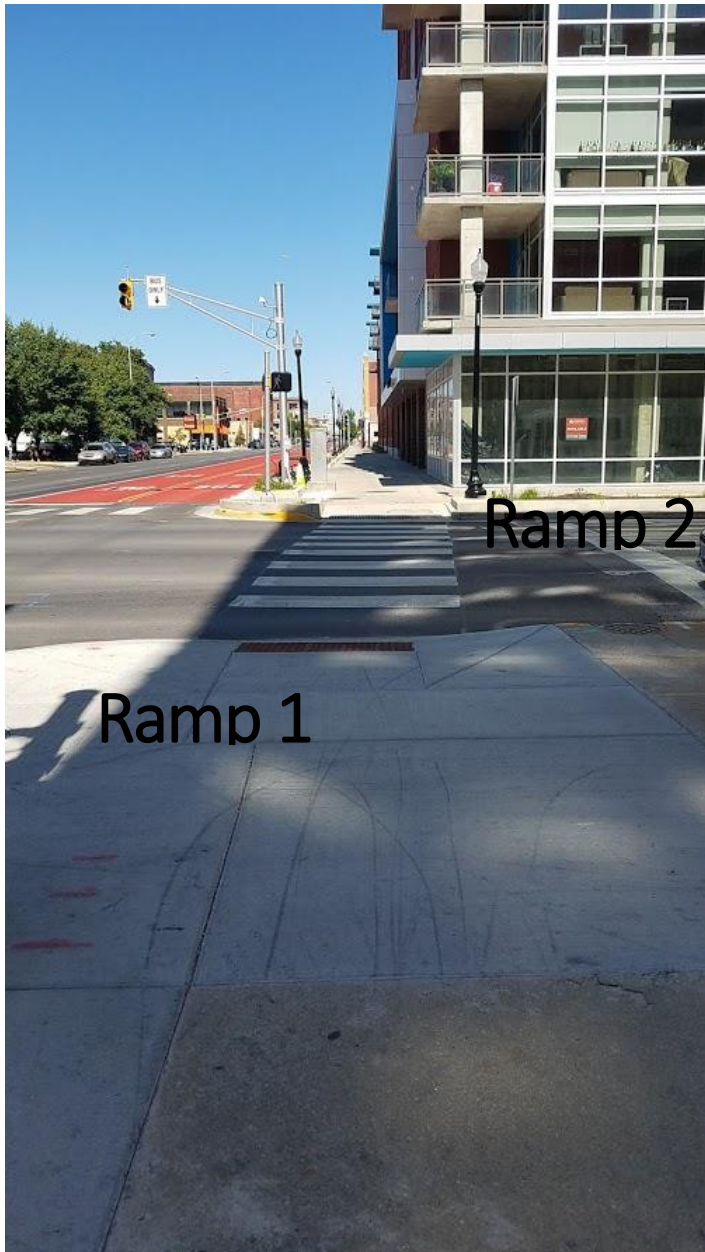
Street 1	Ramp 1 width	Ramp 1 slope	Ramp 1 cross slope	Ramp 1 DWS / transition	Ramp 1 type	Signal button type	Signal button reach	Signal Button height	Signal button size
Street 2									
Burdock Main Street	4'	6.7%	2.8%	Flush	Perpendicular	None	n/a	n/a	n/a
	Ramp 2 width	Ramp 2 slope	Ramp 2 cross slope	Ramp 2 DWS / transition	Ramp 2 type	Signal button type	Signal button reach	Signal Button height	Signal button size
	4'	8.1%	1.8%	flush	Perpendicular	APS	8.9"	39"	2"
	Sidewalk Width / slope	Sidewalk obstructions / pinch points	Near Transit? (within 0.5 mile)	Near School? (within 0.5 mile)	Near Hospital? (within 0.5 mile)	Near Gov't? (within 0.5 mile)	Near Soc. Services? (within 0.5 mile)	Near Park? (within 0.5 mile)	Complaints? (number)
	6'	None	yes	yes	yes	yes	yes	Yes	0
Comments / Notes:									
Detectable warning surface is lifting up on one corner and ramp 1 is collecting debris from drainage. There is a piece of concrete missing from the curb leaving a 2" by 3" hole at bottom of ramp.

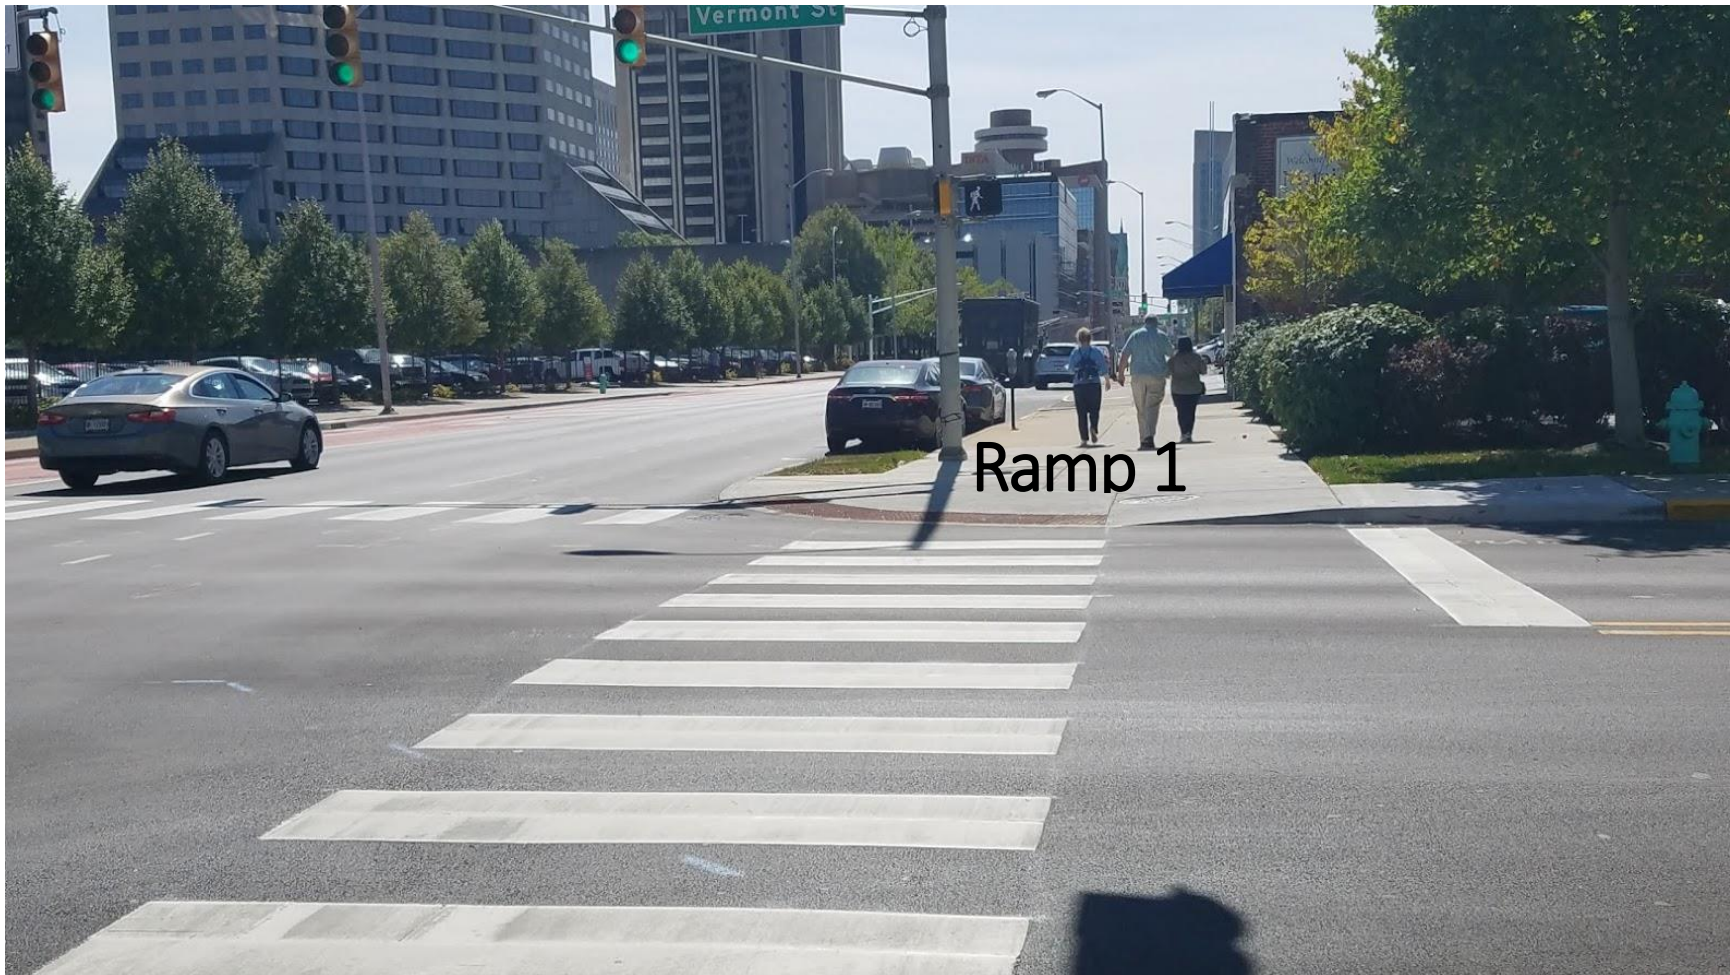
Street 1	Ramp 1 width	Ramp 1 slope	Ramp 1 cross slope	Ramp 1 DWS / transition	Ramp 1 type	Signal button type	Signal button reach	Signal Button height	Signal button size
Street 2									
Larsen St.	13'	4.87%	1.6%	Flush	Depressed corner	None	n/a	n/a	n/a
Main Street.	Ramp 2 width	Ramp 2 slope	Ramp 2 cross slope	Ramp 2 DWS / transition	Ramp 2 type	Signal button type	Signal button reach	Signal Button height	Signal button size
	n/a	n/a	n/a	n/a	n/a	n/a	n/a	n/a	n/a
	Sidewalk Width / slope	Sidewalk obstructions / pinch points	Near Transit? (within 0.5 mile)	Near School? (within 0.5 mile)	Near Hospital? (within 0.5 mile)	Near Gov't? (within 0.5 mile)	Near Soc. Services? (within 0.5 mile)	Near Park? (within 0.5 mile)	Complaints? (number)
	8'	None	yes	yes	yes	yes	yes	yes	0
Comments / Notes:									
New curb ramps along transit corridor.

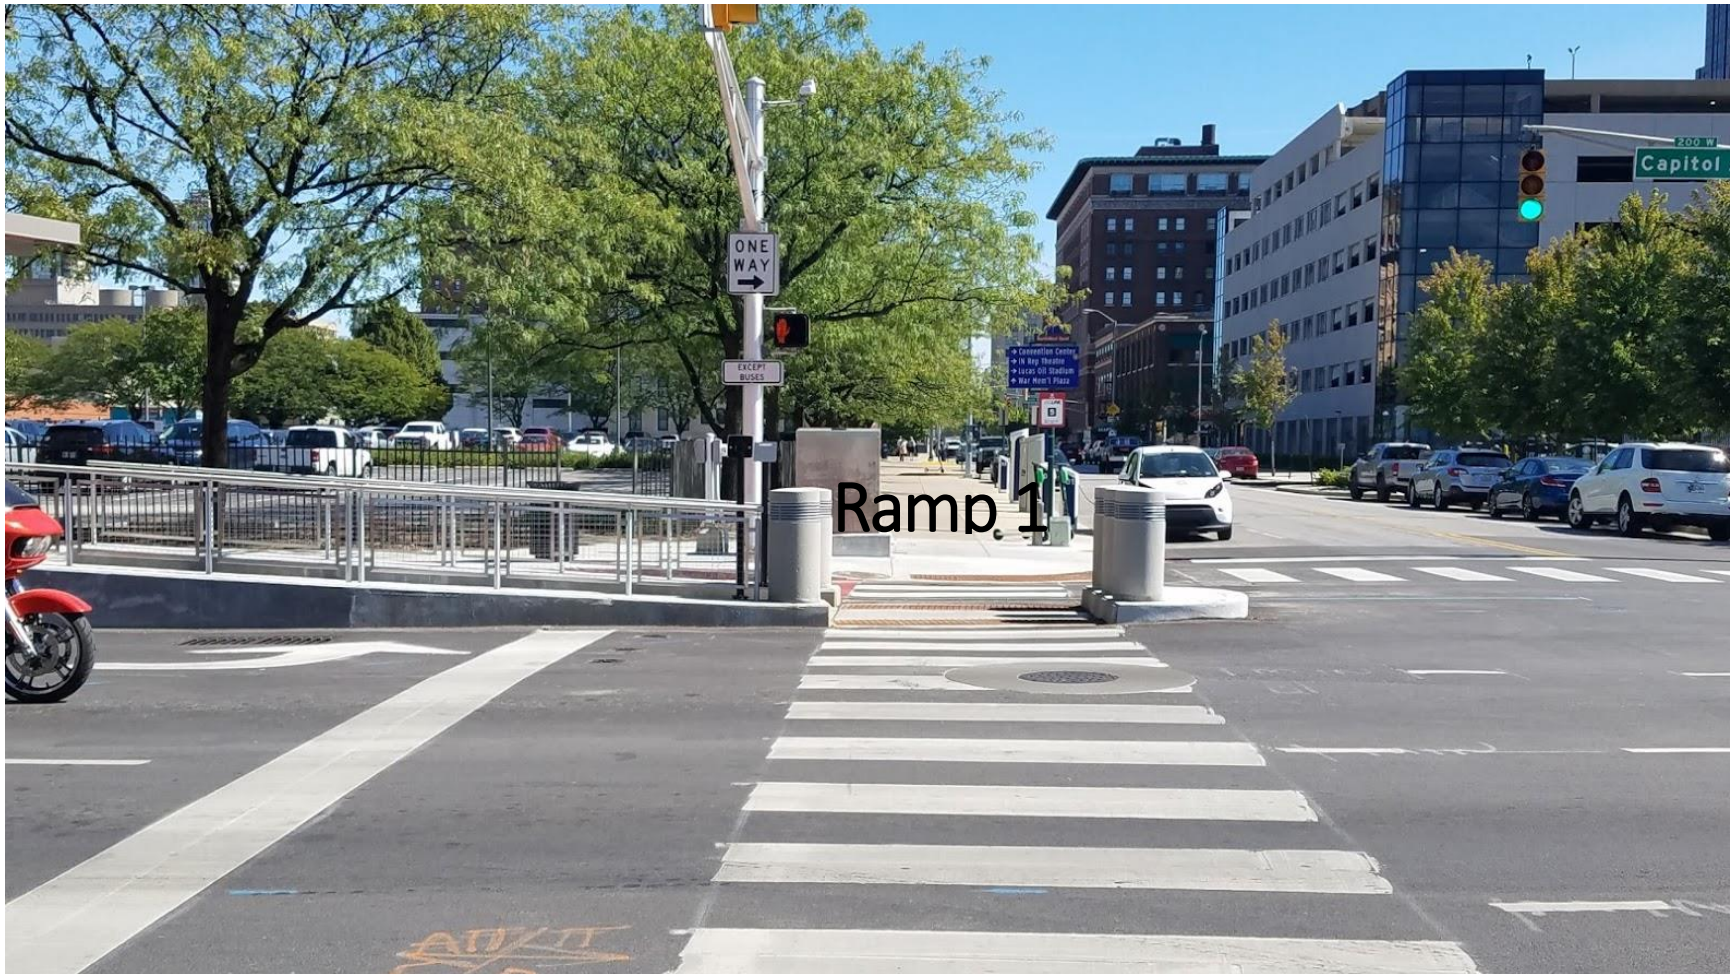
Street 1 Street 2	Ramp 1 width	Ramp 1 slope	Ramp 1 cross slope	Ramp 1 DWS / transition	Ramp 1 type	Signal button type	Signal button reach	Signal Button height	Signal button size
South Station Main Street	11.5'	2.9%	1.4%	Flush	Blended transition	Aps	11"	38.5"	2"
	Ramp 2 width	Ramp 2 slope	Ramp 2 cross slope	Ramp 2 DWS / transition	Ramp 2 type	Signal button type	Signal button reach	Signal Button height	Signal button size
	n/a	n/a	n/a	n/a	n/a	APS	8"	39"	2"
	Sidewalk Width / slope	Sidewalk obstructions / pinch points	Near Transit? (within 0.5 mile)	Near School? (within 0.5 mile)	Near Hospital? (within 0.5 mile)	Near Gov't? (within 0.5 mile)	Near Soc. Services? (within 0.5 mile)	Near Park? (within 0.5 mile)	Complaints? (number)
	8'	Signal box, pushbutton pole, light pole, trash can	yes	yes	yes	yes	yes	yes	3
Comments / Notes:									
Three complaints this month about sidewalk obstructions making it difficult to reach the ramp leading to the station. The pushbuttons and signal cabinet make the passage too narrow for most wheelchairs.

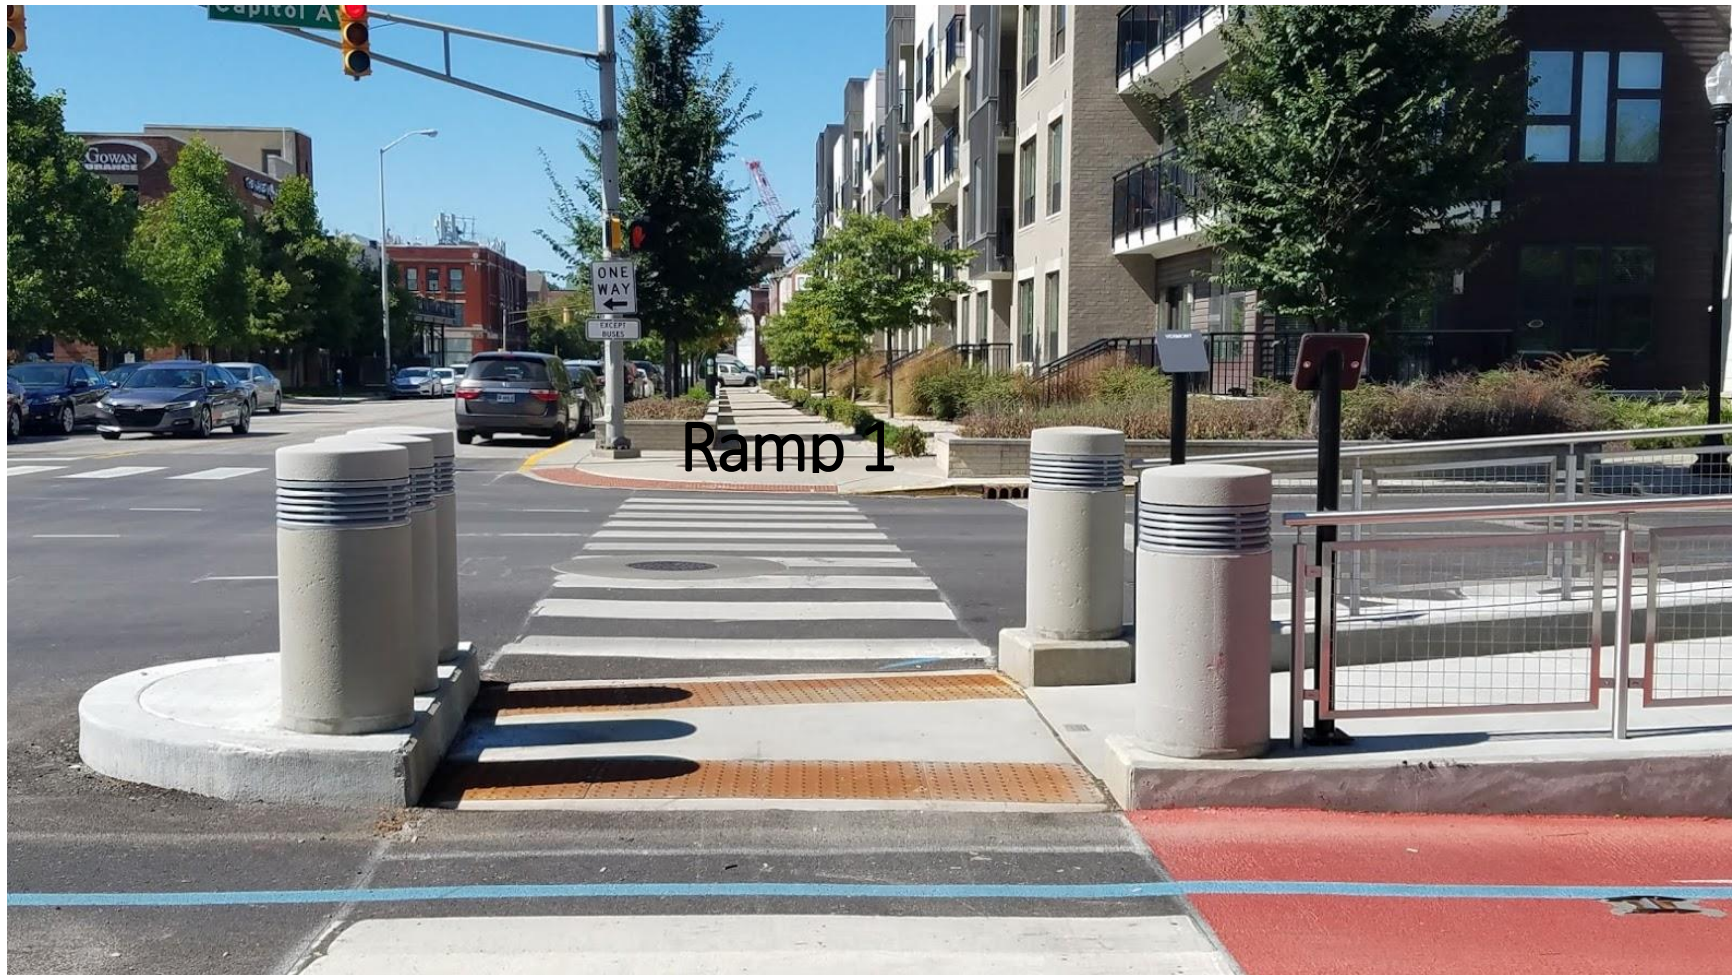
Street 1 Street 2	Ramp 1 width	Ramp 1 slope	Ramp 1 cross slope	Ramp 1 DWS / transition	Ramp 1 type	Signal button type	Signal button reach	Signal Button height	Signal button size
Midway station	17'	0.6%	1.8%	flush	Blended transition	None	n/a	n/a	n/a
Main street	Ramp 2 width	Ramp 2 slope	Ramp 2 cross slope	Ramp 2 DWS / transition	Ramp 2 type	Signal button type	Signal button reach	Signal Button height	Signal button size
	n/a	n/a	n/a	n/a	n/a	n/a	n/a	n/a	n/a
	Sidewalk Width / slope	Sidewalk obstructions / pinch points	Near Transit? (within 0.5 mile)	Near School? (within 0.5 mile)	Near Hospital? (within 0.5 mile)	Near Gov't? (within 0.5 mile)	Near Soc. Services? (within 0.5 mile)	Near Park? (within 0.5 mile)	Complaints? (number)
	8' at 1.9%	None	Yes	yes	yes	yes	yes	yes	0
Comments / Notes:									
Maintenance department observed new ramp collect and holds water following moderate to average rainfall event.

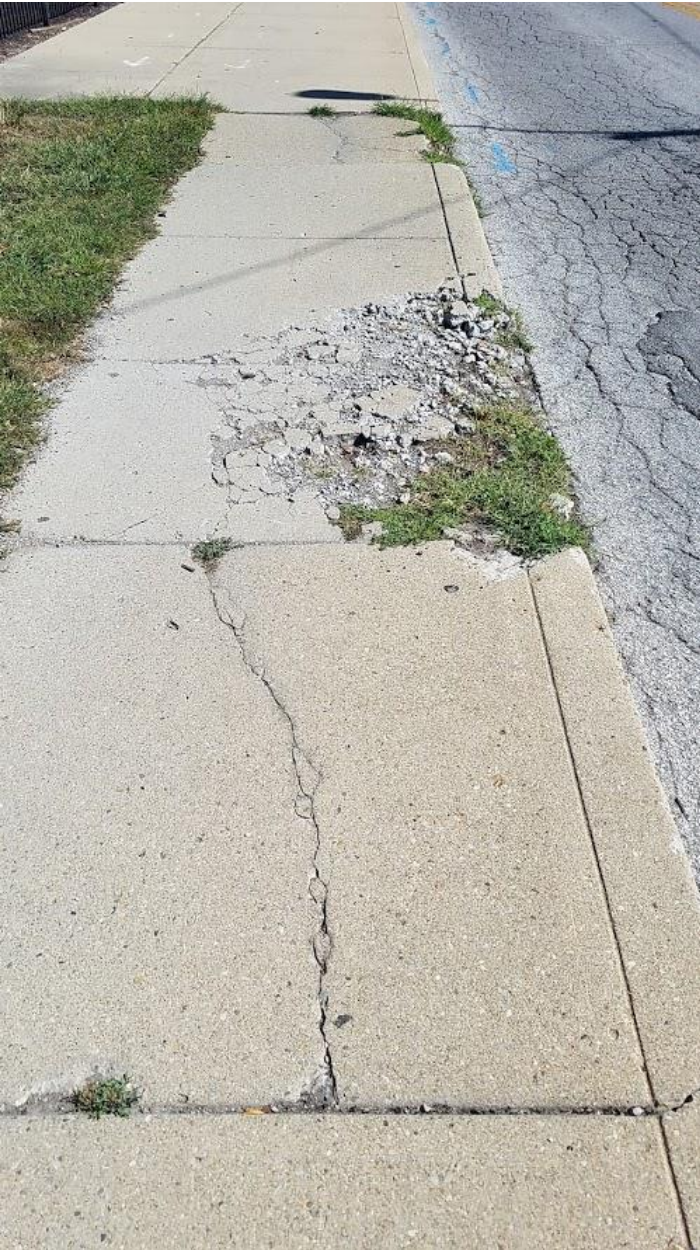
2.8'	Narrower sidewalk ties into new sidewalk	yes	yes	no	no	yes	no	1
Comments / Notes:									
Disabled resident is unable to access nearby transit and services because this portion of sidewalk is a barrier to travel from her residence to transit. Resident currently uses paratransit services but could use and would prefer to use the new bus rapid transit if this barrier were addressed. Sidewalk is crumbling and too narrow. Approximately ½ block of sidewalk would need to be replaced to address barrier.

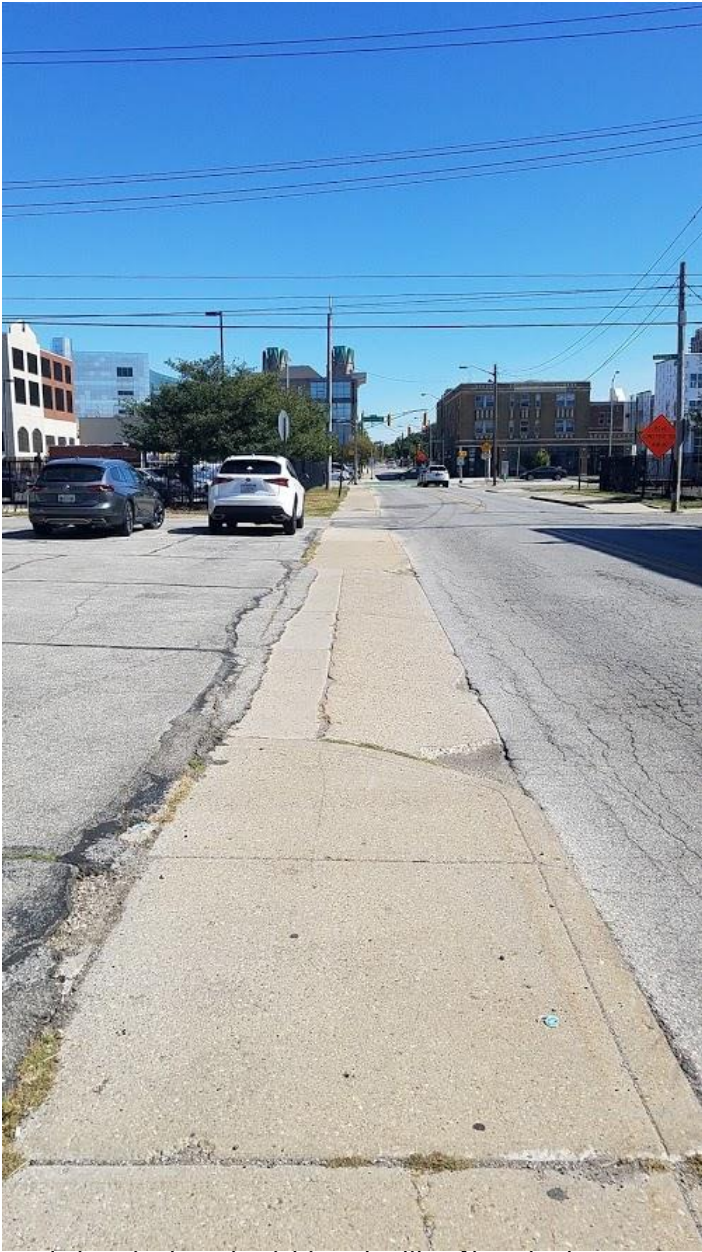
Street 1	Ramp 1 width	Ramp 1 slope	Ramp 1 cross slope	Ramp 1 DWS / transition	Ramp 1 type	Signal button type	Signal button reach	Signal Button height	Signal button size
Street 2									
Morningstar Lane	Ramp 2 width	Ramp 2 slope	Ramp 2 cross slope	Ramp 2 DWS / transition	Ramp 2 type	Signal button type	Signal button reach	Signal Button height	Signal button size
Main street									
	Sidewalk Width / slope	Sidewalk obstructions / pinch points	Near Transit? (within 0.5 mile)	Near School? (within 0.5 mile)	Near Hospital? (within 0.5 mile)	Near Gov't? (within 0.5 mile)	Near Soc. Services? (within 0.5 mile)	Near Park? (within 0.5 mile)	Complaints? (number)
	4'	Pavement cracked / missing	yes	yes	yes	yes	yes	yes	0
Comments / Notes:									
This is the better side of the street between the assessor's office and the bus stop. Pavement should be replaced to make transit travel to assessor's office possible.

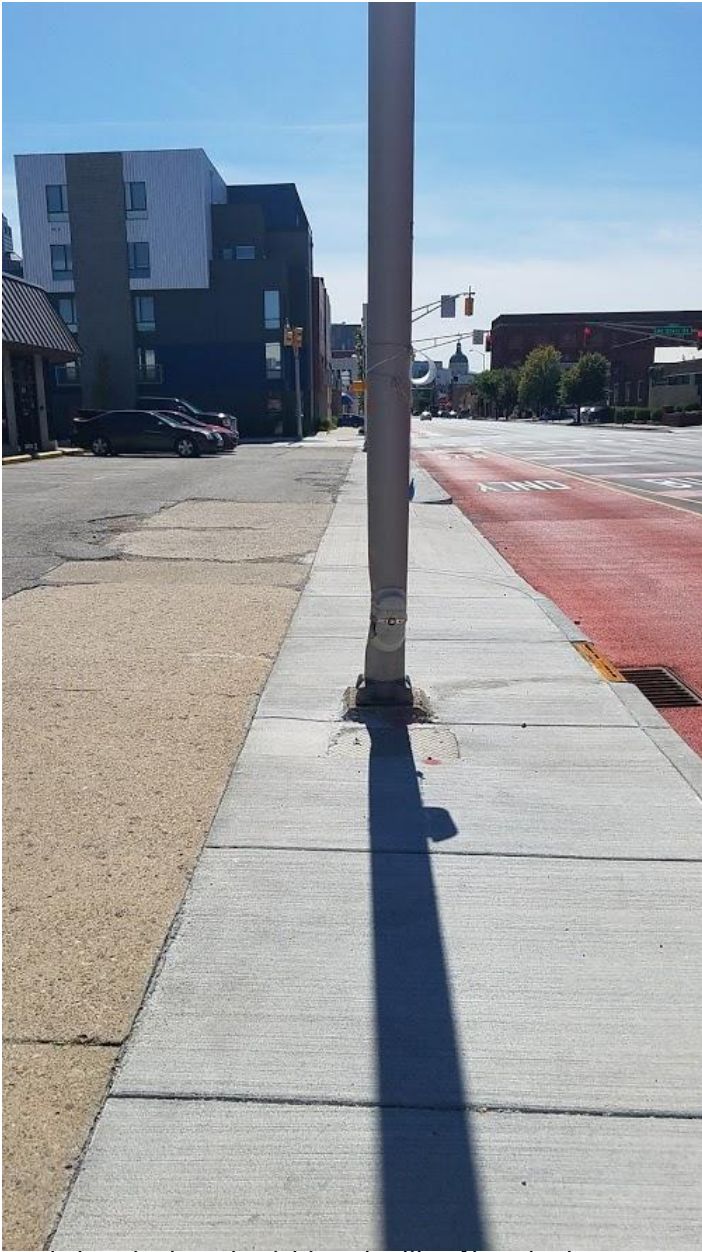
Street 1	Ramp 1 width	Ramp 1 slope	Ramp 1 cross slope	Ramp 1 DWS / transition	Ramp 1 type	Signal button type	Signal button reach	Signal Button height	Signal button size
Street 2									
Main Street									
Between farmers & first street, west side	Ramp 2 width	Ramp 2 slope	Ramp 2 cross slope	Ramp 2 DWS / transition	Ramp 2 type	Signal button type	Signal button reach	Signal Button height	Signal button size
	Sidewalk Width / slope	Sidewalk obstructions / pinch points	Near Transit? (within 0.5 mile)	Near School? (within 0.5 mile)	Near Hospital? (within 0.5 mile)	Near Gov't? (within 0.5 mile)	Near Soc. Services? (within 0.5 mile)	Near Park? (within 0.5 mile)	Complaints? (number)
	5'	Poles in middle of new sidewalk	Yes, along route	yes	yes	yes	yes	yes	0
Comments / Notes:									
While it is feasible to move around pole by traveling onto private lot, this may not be possible when vehicles are parked here or if the site is redeveloped. Poles should be relocated to remove barrier.

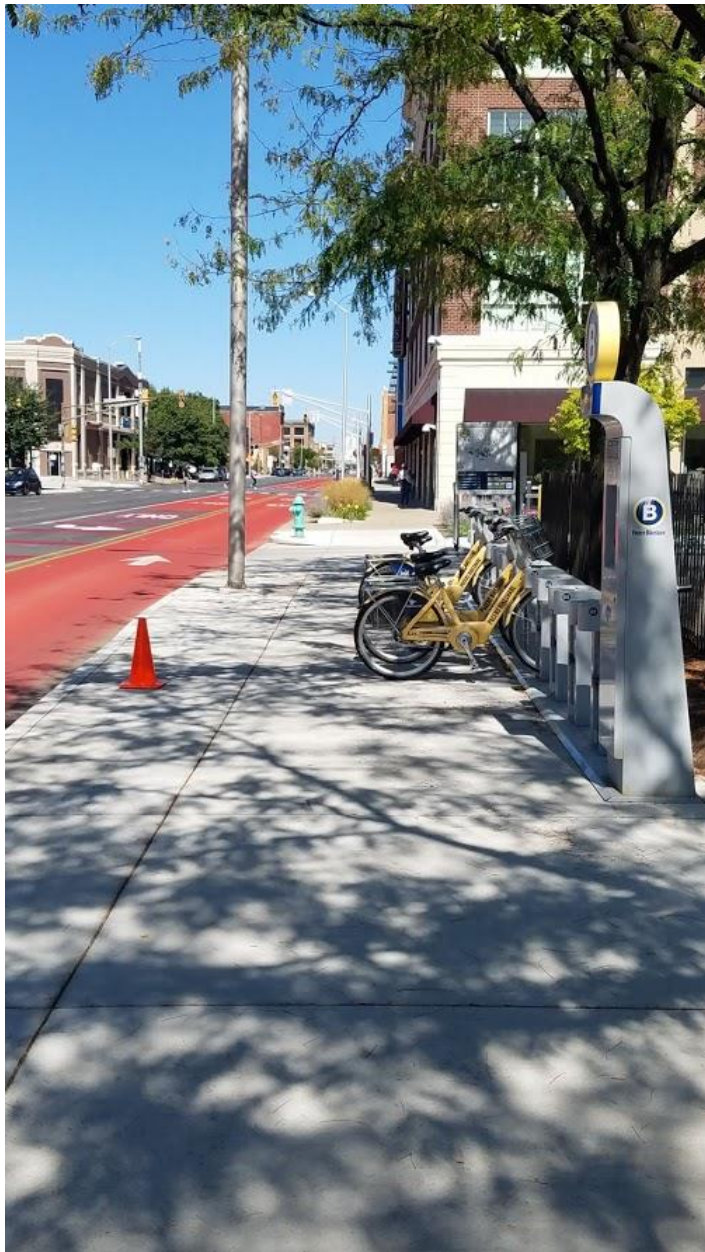
Street 1	Ramp 1 width	Ramp 1 slope	Ramp 1 cross slope	Ramp 1 DWS / transition	Ramp 1 type	Signal button type	Signal button reach	Signal Button height	Signal button size
Street 2									
Main Street	n/a	n/a	n/a	n/a	n/a	n/a	n/a	n/a	n/a
n/a	Ramp 2 width	Ramp 2 slope	Ramp 2 cross slope	Ramp 2 DWS / transition	Ramp 2 type	Signal button type	Signal button reach	Signal Button height	Signal button size
	n/a	n/a	n/a	n/a	n/a	n/a	n/a	n/a	n/a
	Sidewalk Width / slope	Sidewalk obstructions / pinch points	Near Transit? (within 0.5 mile)	Near School? (within 0.5 mile)	Near Hospital? (within 0.5 mile)	Near Gov't? (within 0.5 mile)	Near Soc. Services? (within 0.5 mile)	Near Park? (within 0.5 mile)	Complaints? (number)
	12 ft / 1.6%	> 5 ft	adjacent	No	Yes	Yes	Yes	No	0
Comments / Notes:									
Sidewalk level along entire block, no pinch points less than 5 feet. Bicycle station / hydrants and poles do make weaving necessary.
